Final Report
Project NV054

Investigation of Preservative Treated Plantation Timber Fencing and Sleeper Markets in Bushfire Prone Areas

Project No: NIF144-2122 [NV054]

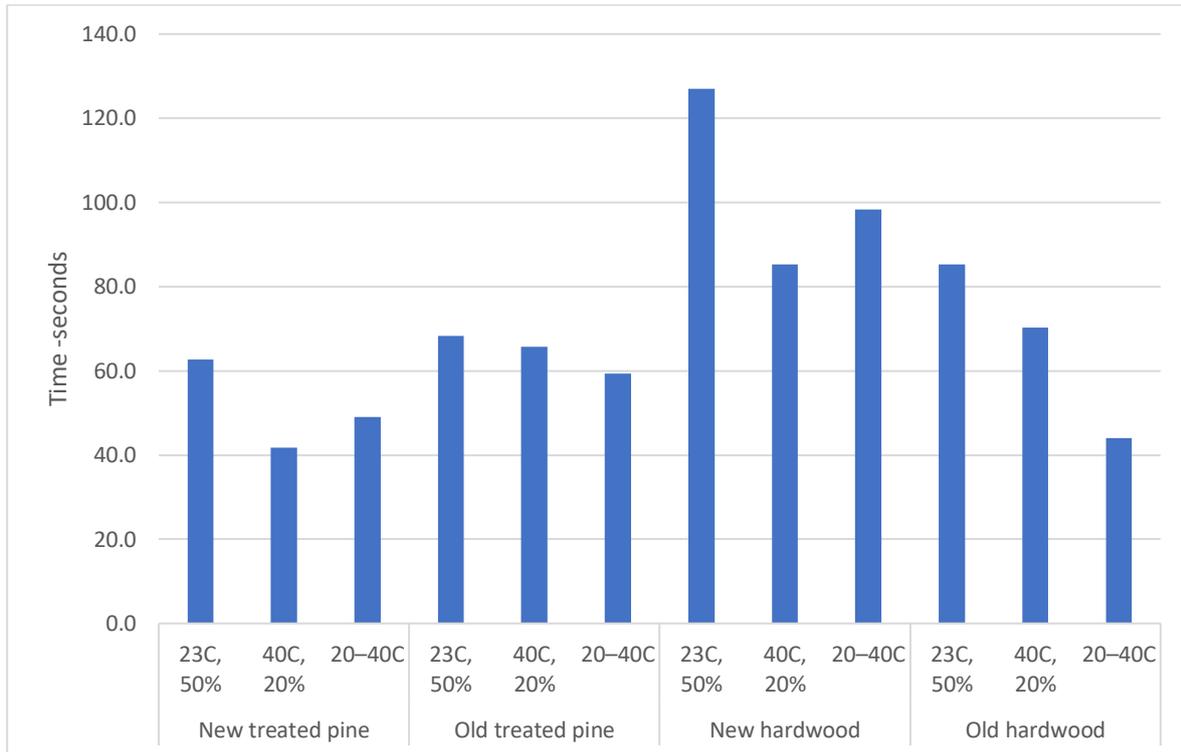
Figure 2 Mean time to ignition for samples of timber palings - derived from data presented in (Leonard, Bianchi et al. 2006)

The mean ignition times for the different specimens are plotted in Figure 2. The heat release rate (HRR) is also a fire property that significantly influences the potential for fire spread. This parameter has been plotted for comparison in Figure 3 using data available and the variation between differently conditioned samples of the same species is relatively minor indicating that the impact of moisture content is predominantly related to the time to ignition with the post ignition behaviour being less sensitive to moisture content. This highlights the potential for pre-wetting treated pine fencing during days of high fire risk as a method to reduce the risk of ignition if exposed to bushfire attack to reduce the sensitivity to environmental conditions.

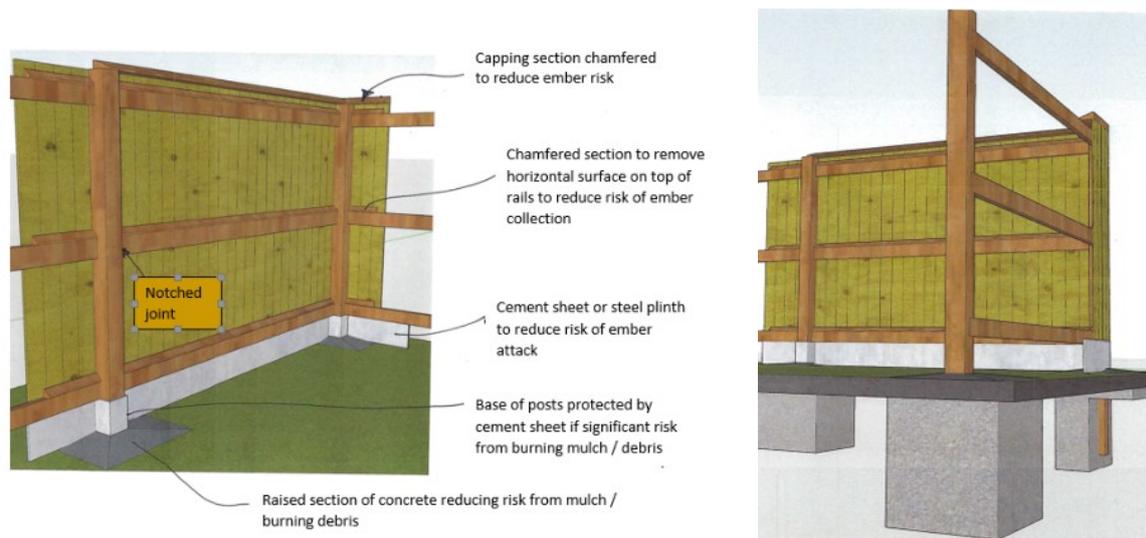
Figure 8 Paling fence designed to shed embers and resist ignition by collections of burning debris at the base of the fence

Potential enhancements including ember shedding features such as rail wedges and non-combustible plinths were also developed as shown in Figure 9 but could not be accommodated in the original large scale testing program.

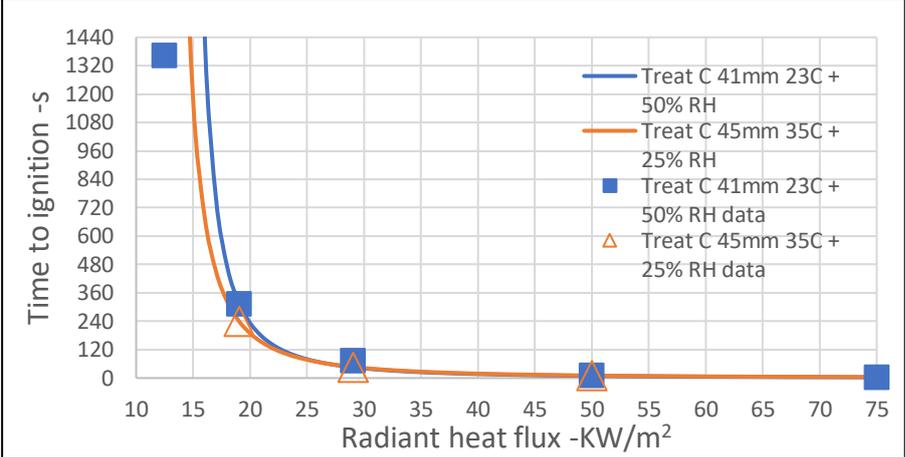
Figure 10 Plots of time to ignition for Radiata Pine with preservative treatment C(H4) based on Janssens method

For the thicker specimens the specimens tended to behave as thermally thick elements at the time of ignition and therefore the Janssens method was used to determine relationships between the time to ignition and imposed heat flux. Relationships were derived for treated radiata pine after standard conditioning at 23°C and 50% relative humidity and after conditioning at 35°C and 25% relative humidity and are plotted against time in Figure 10.

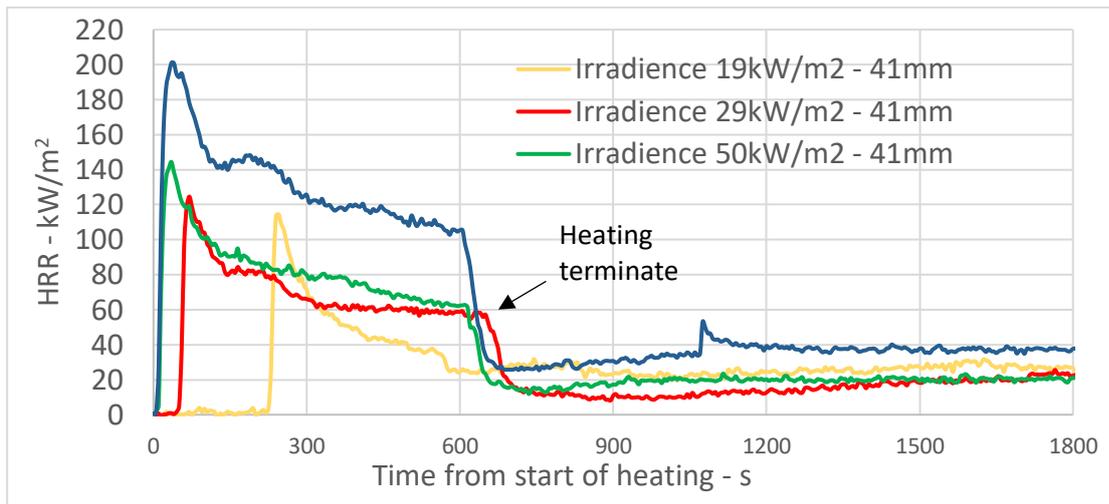
Figure 11 HRR from fire cone calorimeter tests on radiata pine, nominally 41mm thick with preservative treatment C at varying irradiances for a heating duration of 600s after ignition – specimens conditioned at 23°C and 50% relative humidity.

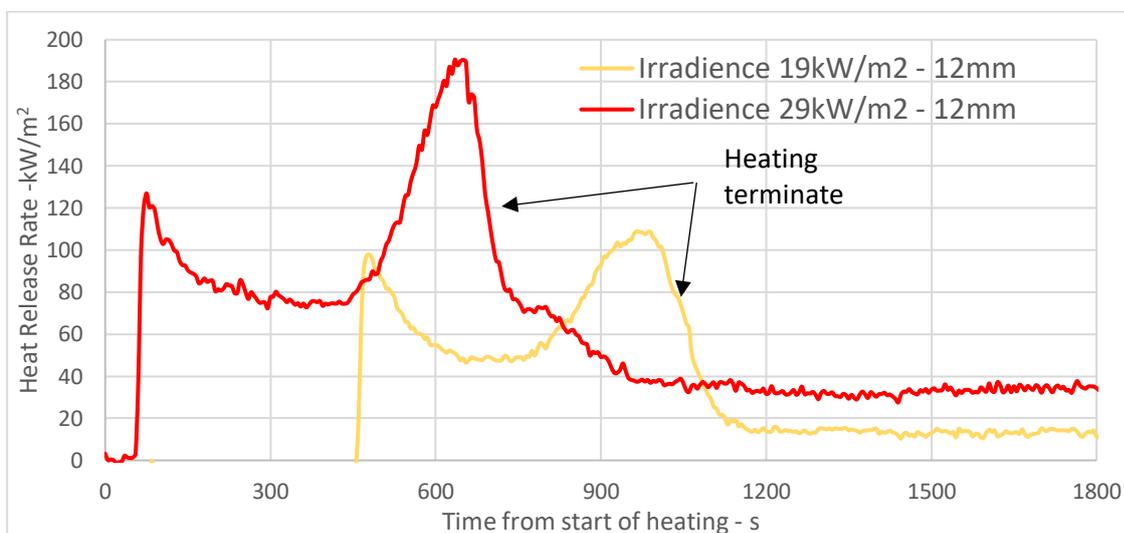
Figure 12 HRR from fire cone calorimeter tests on radiata pine, nominally 12 mm thick with preservative treatment C at varying irradiances for a heating duration of 600s after ignition – specimens conditioned at 23°C and 50% relative humidity.

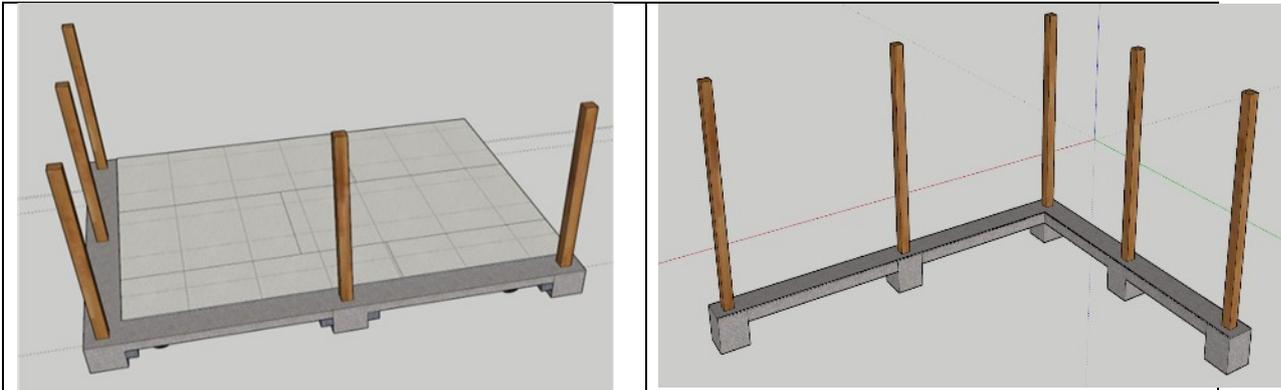
Figure 13 Schematic of test platform and pre-prepared footing assembly prior to mounting on platform

The basic concept comprised a moveable platform on which the reference building could be constructed. Test specimens including footings could be constructed separately and conditioned and then mounted on the platform as shown in Figure 13.

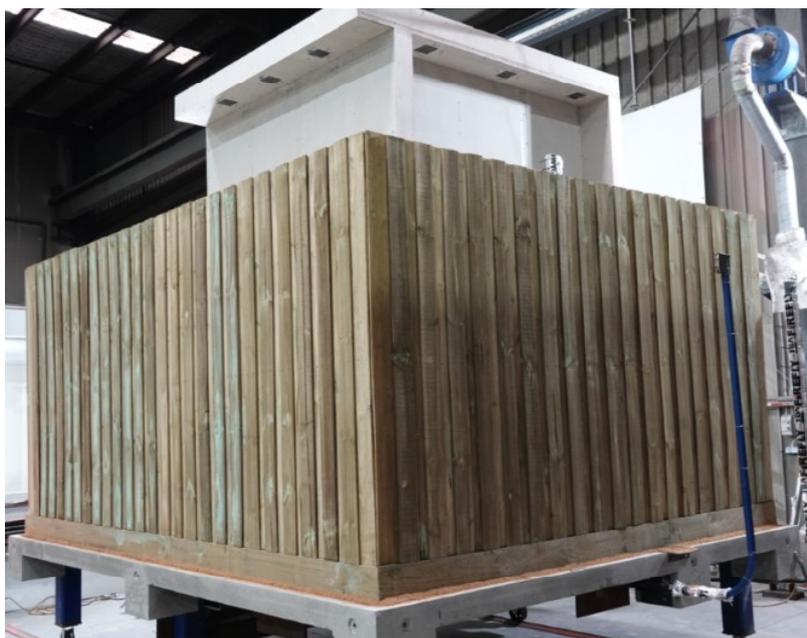
Figure 16 General view of test configuration for fencing tests

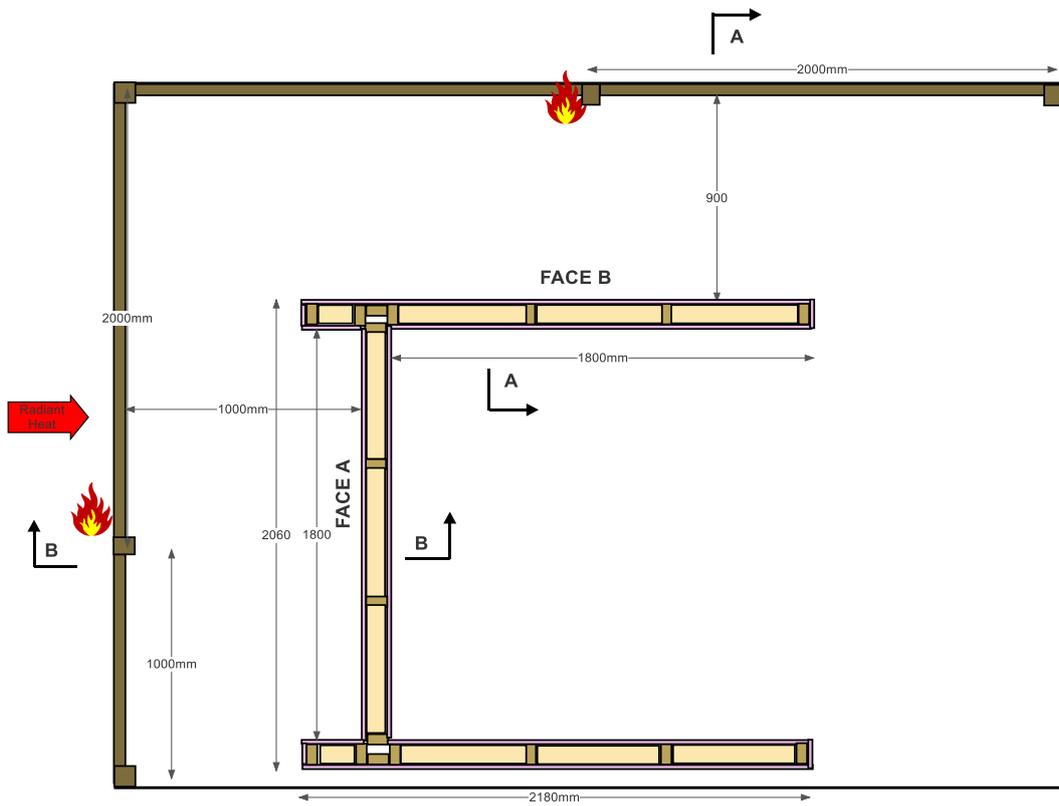
Figure 17 Fence facing bushfire hazard 1m from face of reference building with return running perpendicular to bushfire hazard 900mm from the building

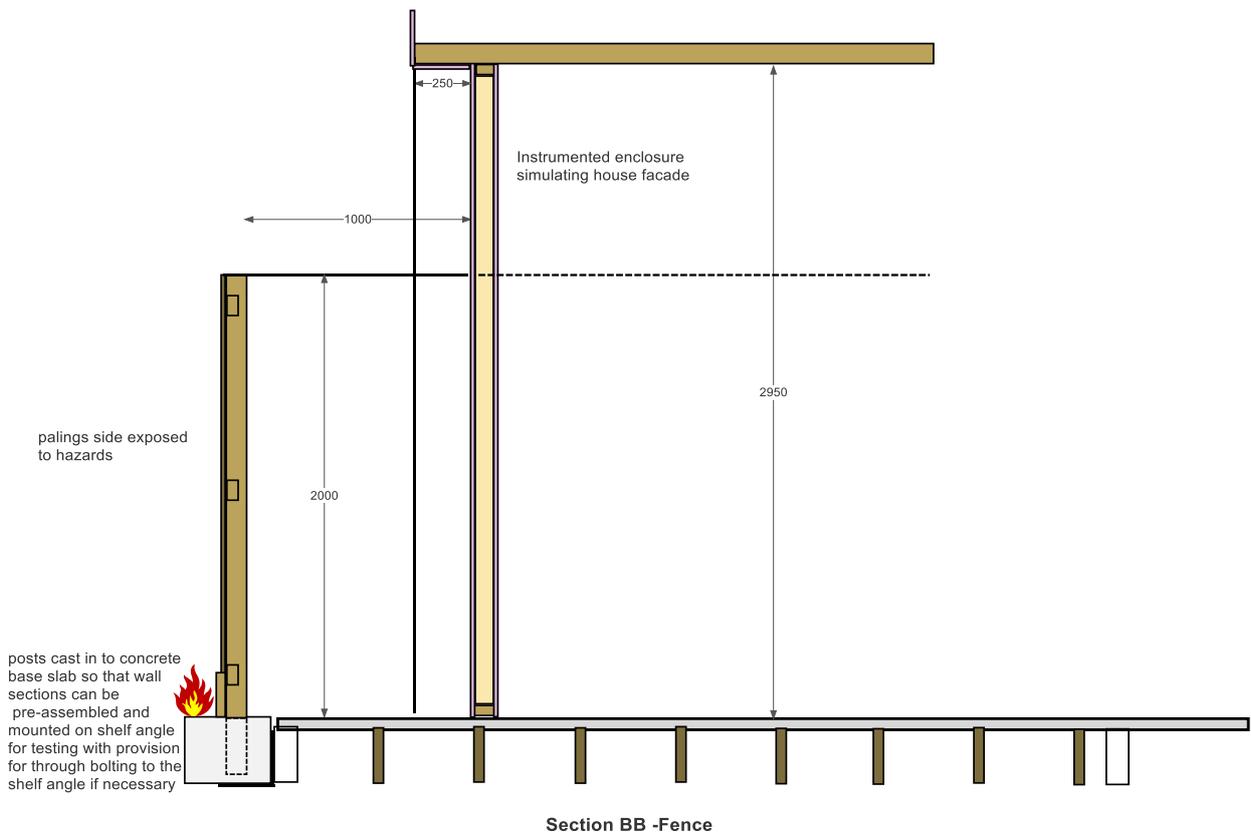
Figure 18 Longitudinal section B-B through fencing and reference building

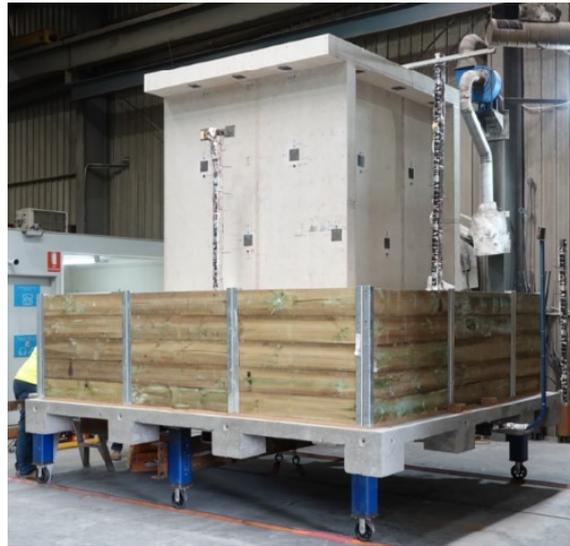
Figure 19 General view of test configuration for sleepers supporting a pathway around a house

The configuration supporting the pathway includes a sleeper wall located 1m in front of the building, directly facing a simulated bushfire as shown in Figure 19 to Figure 21. In this configuration the exposed face will be ignited and the heat flux on the front of the building from the flames and simulated bushfire front will need to be evaluated.

In test 4 a configuration was tested simulating a pathway around the house supported by a retaining wall located 1m in front of the building and on the west side directly facing the radiant heat source, as shown in Figure 19 to Figure 21. In this configuration the exposed sleepers will be ignited and the heat flux on the front of the building could potentially be affected.

The general test configuration is shown in Figure 19 through Figure 21 and simulates a garden wall of maximum height 1m located 1m in front of a building directly facing the fire front. In the test configuration the sleeper wall runs in front of the west face of the reference building which faces the radiant heat source and along the northern side of the reference building to investigate the potential for fire spread perpendicular to the heat source.

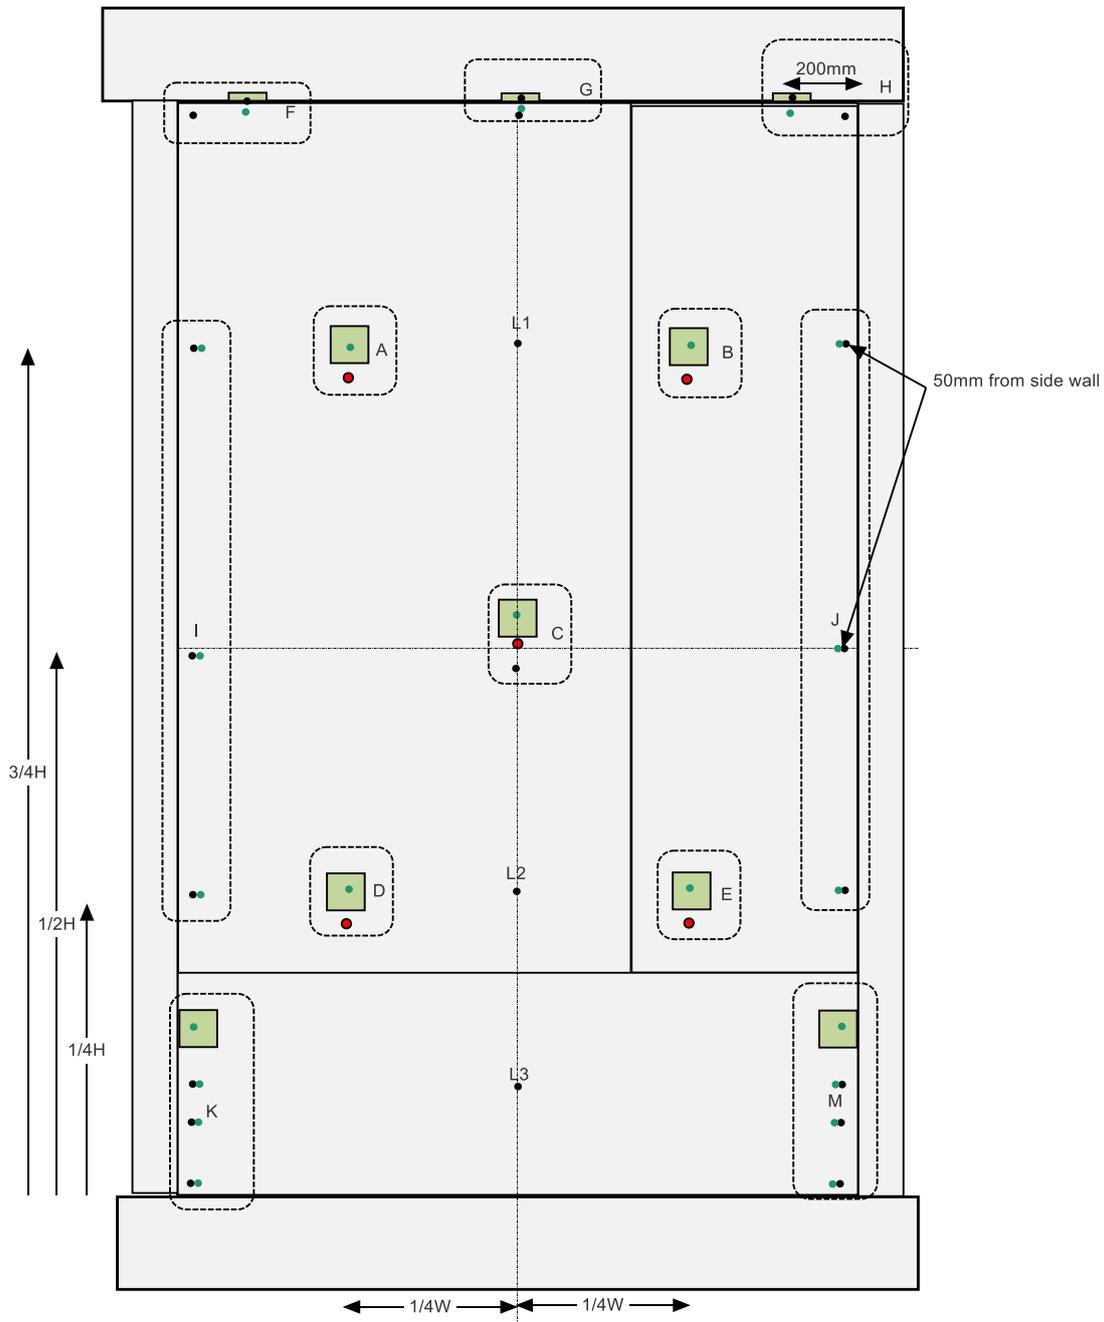
Figure 25 Elevation of west wall of reference building showing instrumentation of building facing the simulated fire source.

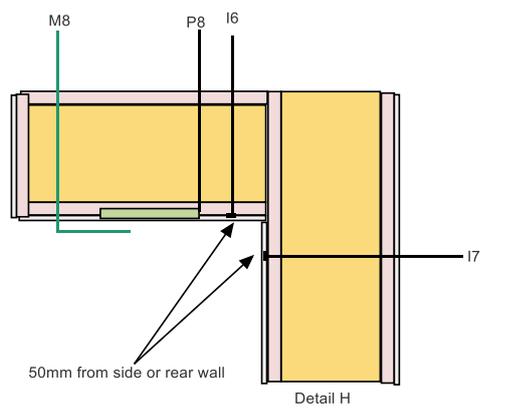
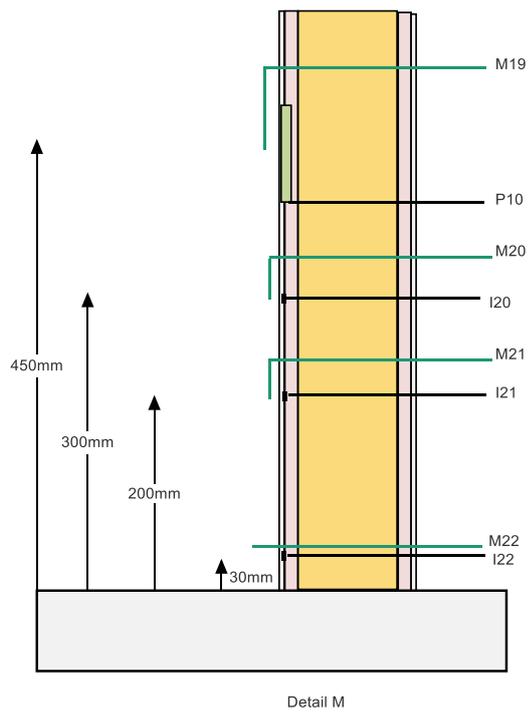
Figure 26 Section showing typical instrumentation details for the west face

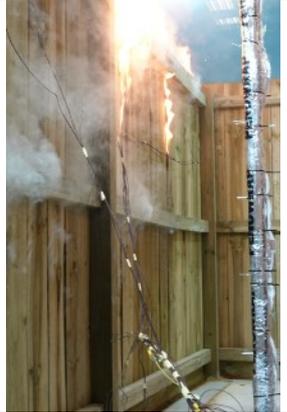
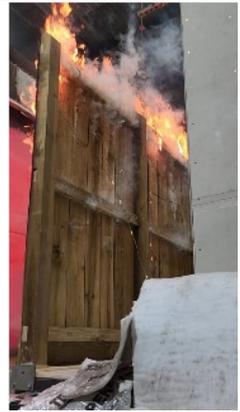
t=5min 30s flames penetrating west fence	t= 6min Internal surface of southwest corner of fence	t=6min 5s flaming substantially reduced on west fence external surface	t=10mins flaming on inner face of west fence

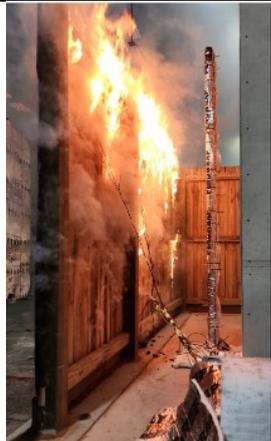
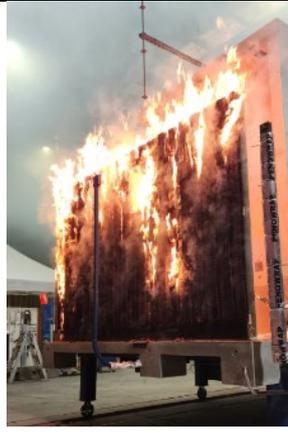
t=10mins flaming on inner face of west fence viewed from southwest corner	t=11min 40s external face of west fence	t=13min 05s external face of fence showing little damage to north section but palings on west section mostly consumed

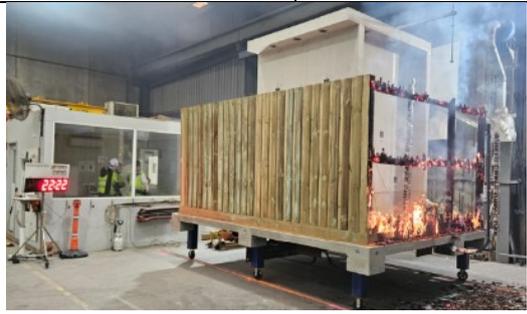
t=22min 22s showing most continuing glowing combustion of upper parts of framing and flaming from base of fence	t=22 min collection of burning debris at base of timber fence	t=30 min rails and posts still in place on western side, flaming embers at base substantially reduced

Figure 31 Test observations from 5-30 minutes from test 1

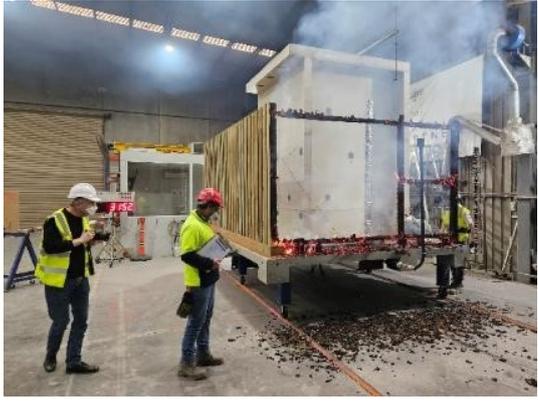
<p>t=30 view heavily charred and smouldering west frame. Discolouration of north wall at corner post</p>	<p>t=31min 52s mid rail falls away from main section of west wall – no damage to reference building or north fence other than associated with NW corner post</p>	<p>t=33min 30s Smouldering combustion of NW corner post showing minor spread to palings</p>

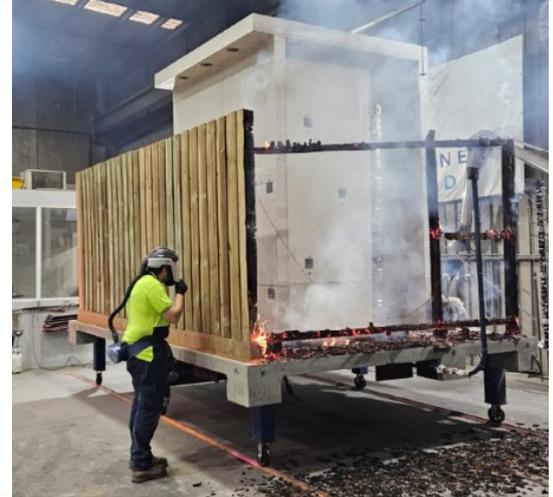
<p>t=37min top rail falling away from northwest post</p>	<p>t=41 min frame members fell away no damage to west face of reference building. NW corner post in place but smouldering. No significant spread to north fence</p>	<p>t=41 min frame members SW corner</p>

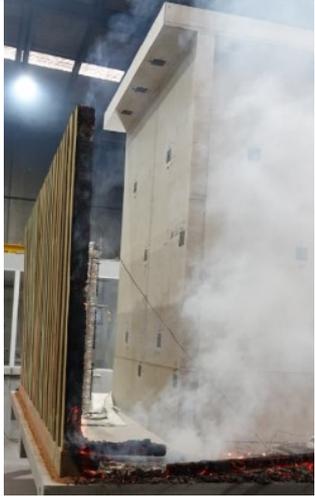
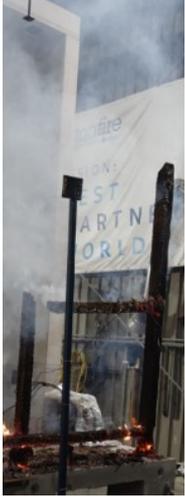
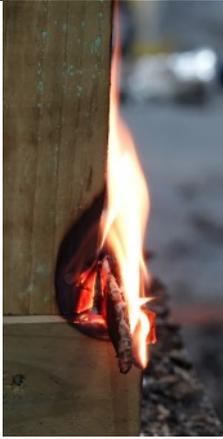
Figure 32 Test observations from 30-85 minutes from test 1

<p>t=85 min Right transition to flaming combustion at base of NW post. Left Flaming combustion from post spreading to palings</p>

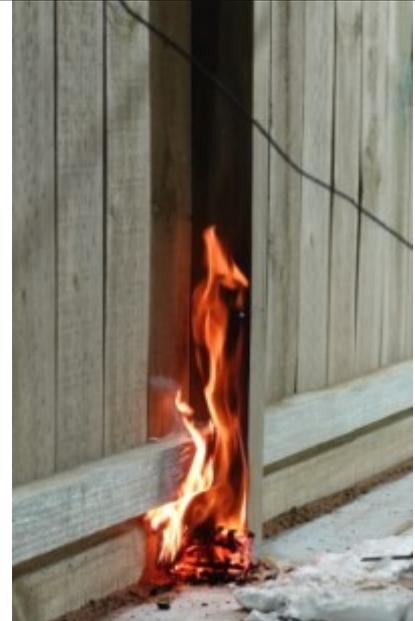
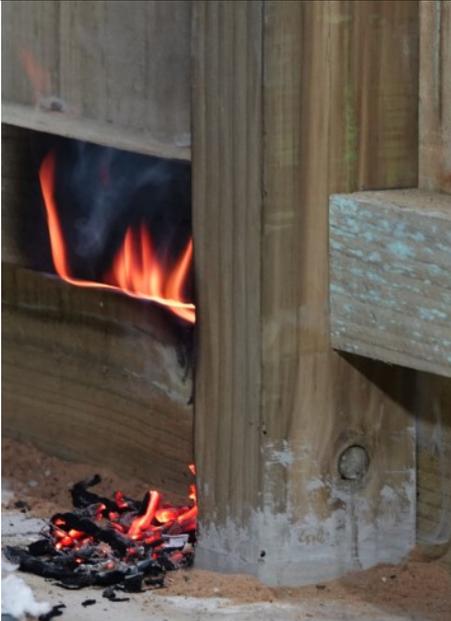
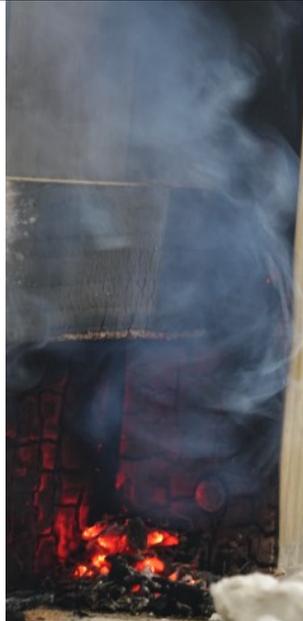
Figure 33 Timber crib test applied to central stud of north wall after approximately 90 minutes of test

<p>t=93min timber crib applied to central post of north fence, igniting post and lower rail</p>	<p>t=97min flaming reduced to lower rail and embers from crib</p>	<p>t=102min flaming of bottom rail stopped. Glowing embers from crib still visible</p>

The west fence was substantially consumed, a section of the north fence adjacent to the west fence was consumed and another section of the north fence was consumed by the central post where a crib was applied 90 minutes after the start of the test.

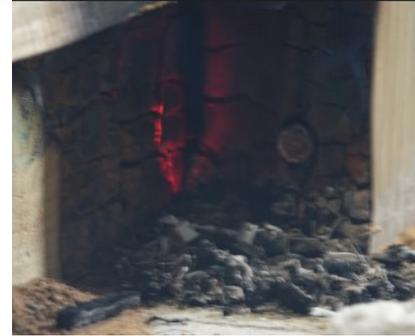
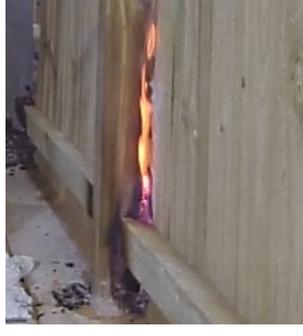
<p>t=122 mins glowing combustion at interface between post and plinth</p>	<p>t=268mins traces of smouldering combustion around centre post</p>	<p>glowing at interface between post rail and palings</p>	<p>transition to flaming combustion on inner face of fence</p>

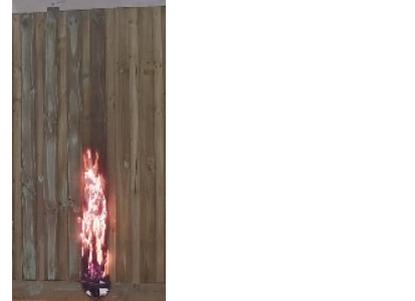
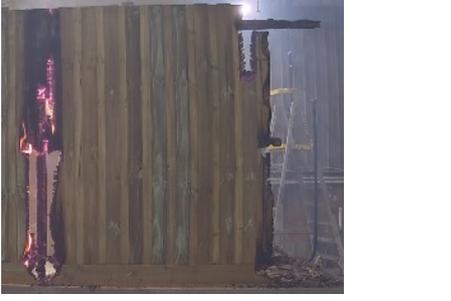
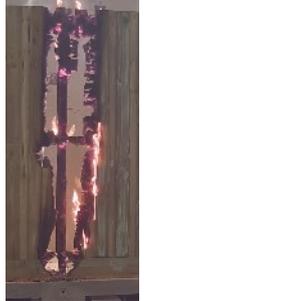
<p>t=290mins burn through and flaming combustion on external surface of fence</p>	<p>t=313 mins palings consumed and / or fallen way around centre post 313</p>	<p>t=331 mins central post north wall</p>

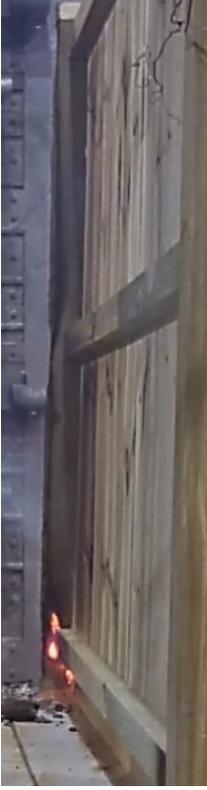
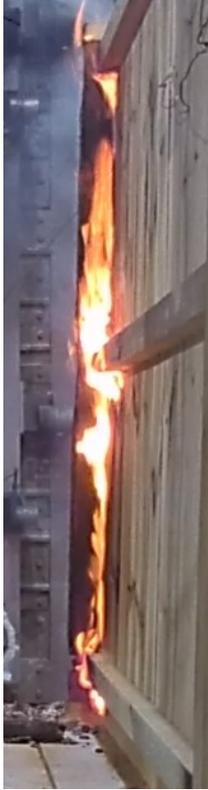
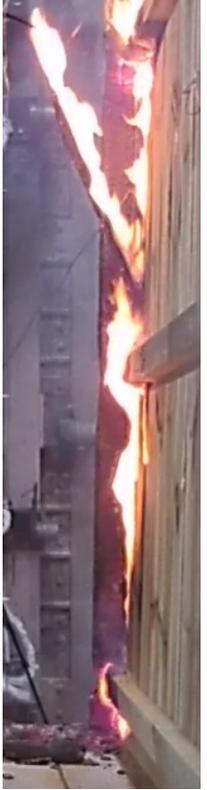
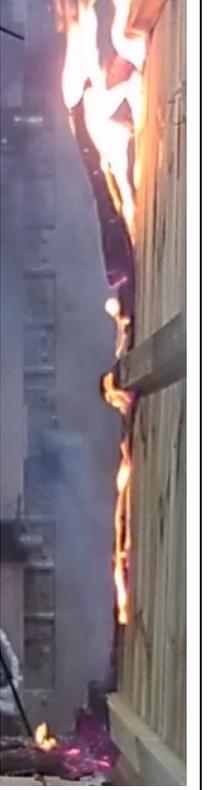
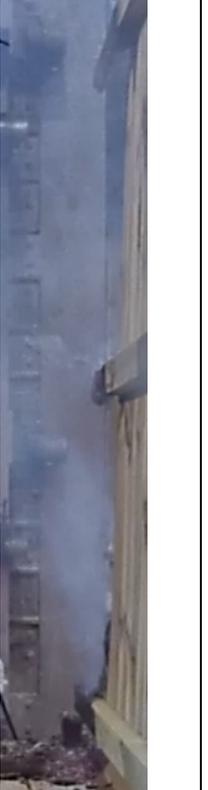
t=142 mins flaming ignition of NW post on internal face of north fence	t=148mins flame spread to palings around NW post	t=158 mins paling falling away adjacent to NW post	t=171 mins NW post falling	t=190 mins flaming combustion stopped at NW corner

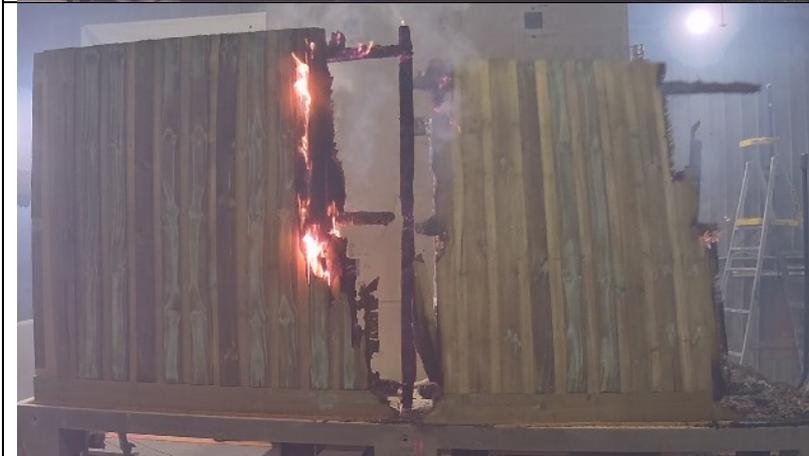
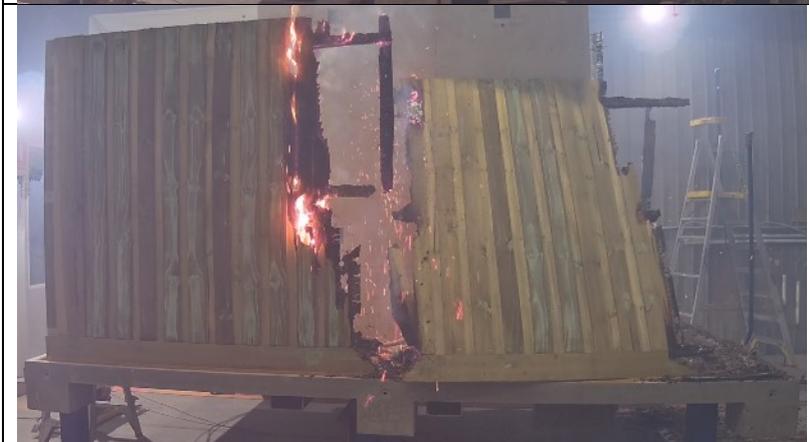
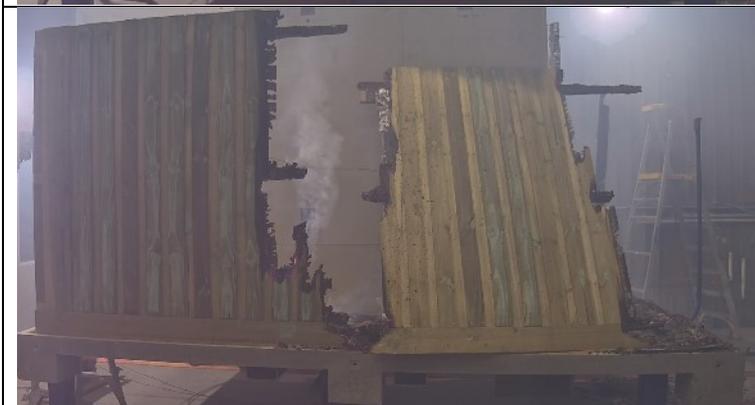
Figure 35 Section of North wall falling towards building after 361 minutes

t=361 mins west end of north wall falls towards the reference building

t=390 mins flaming combustion stopped without manual intervention

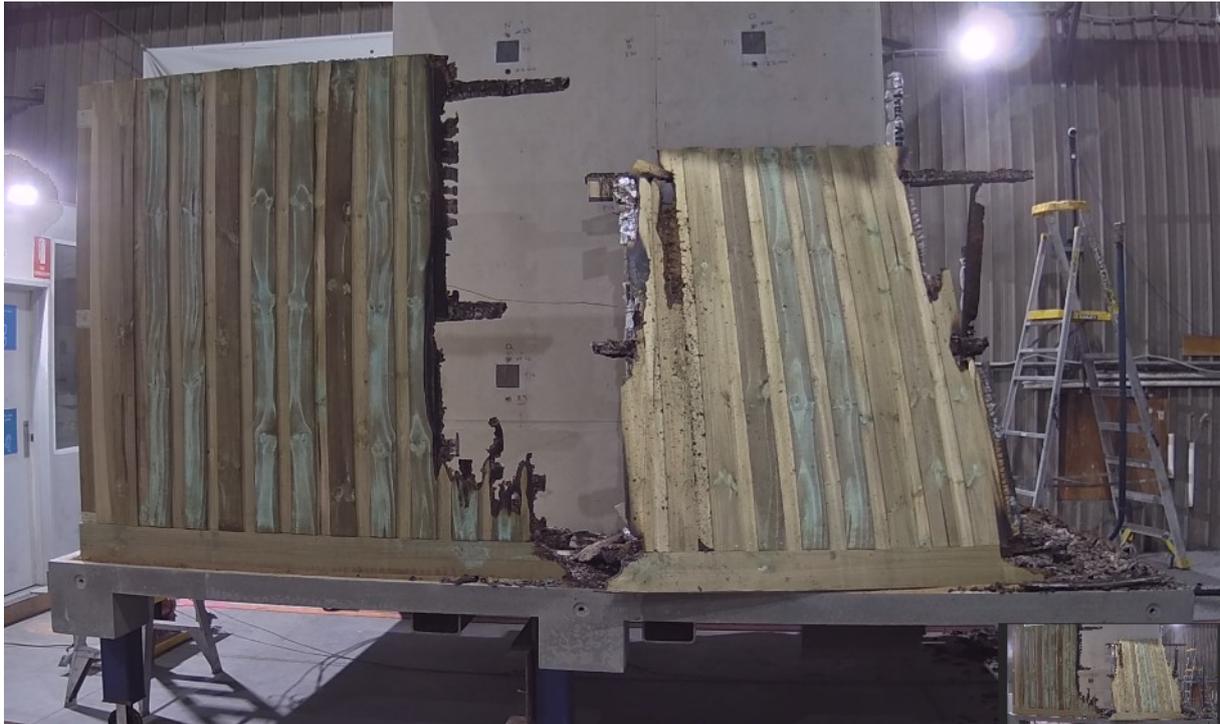
Figure 36 North wall 15.5 hours after commencement with no evidence of ongoing combustion

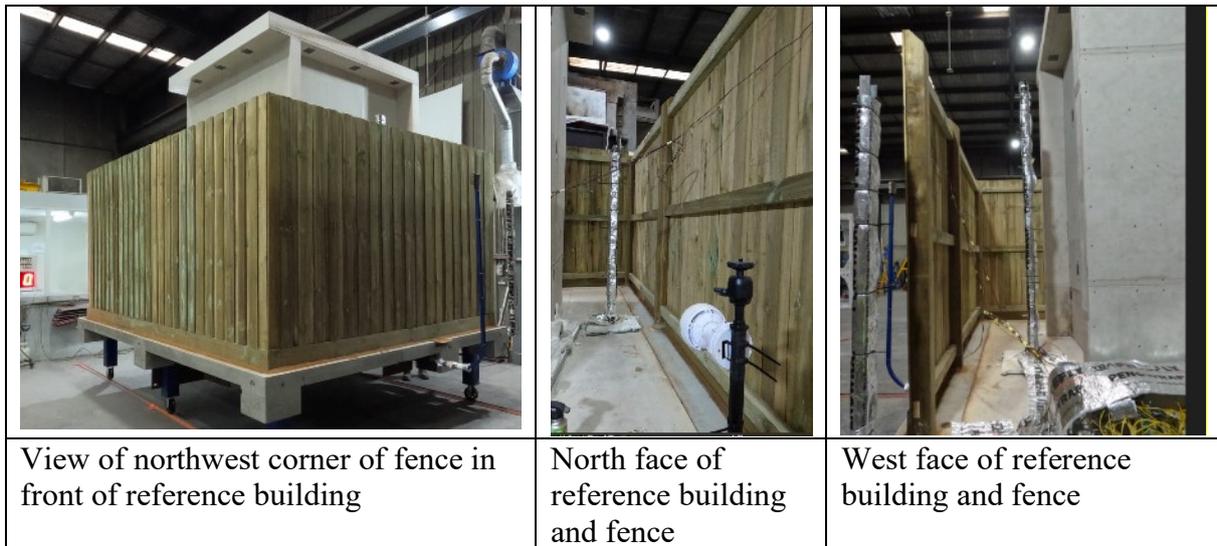
Figure 37 Fence and Reference building before test

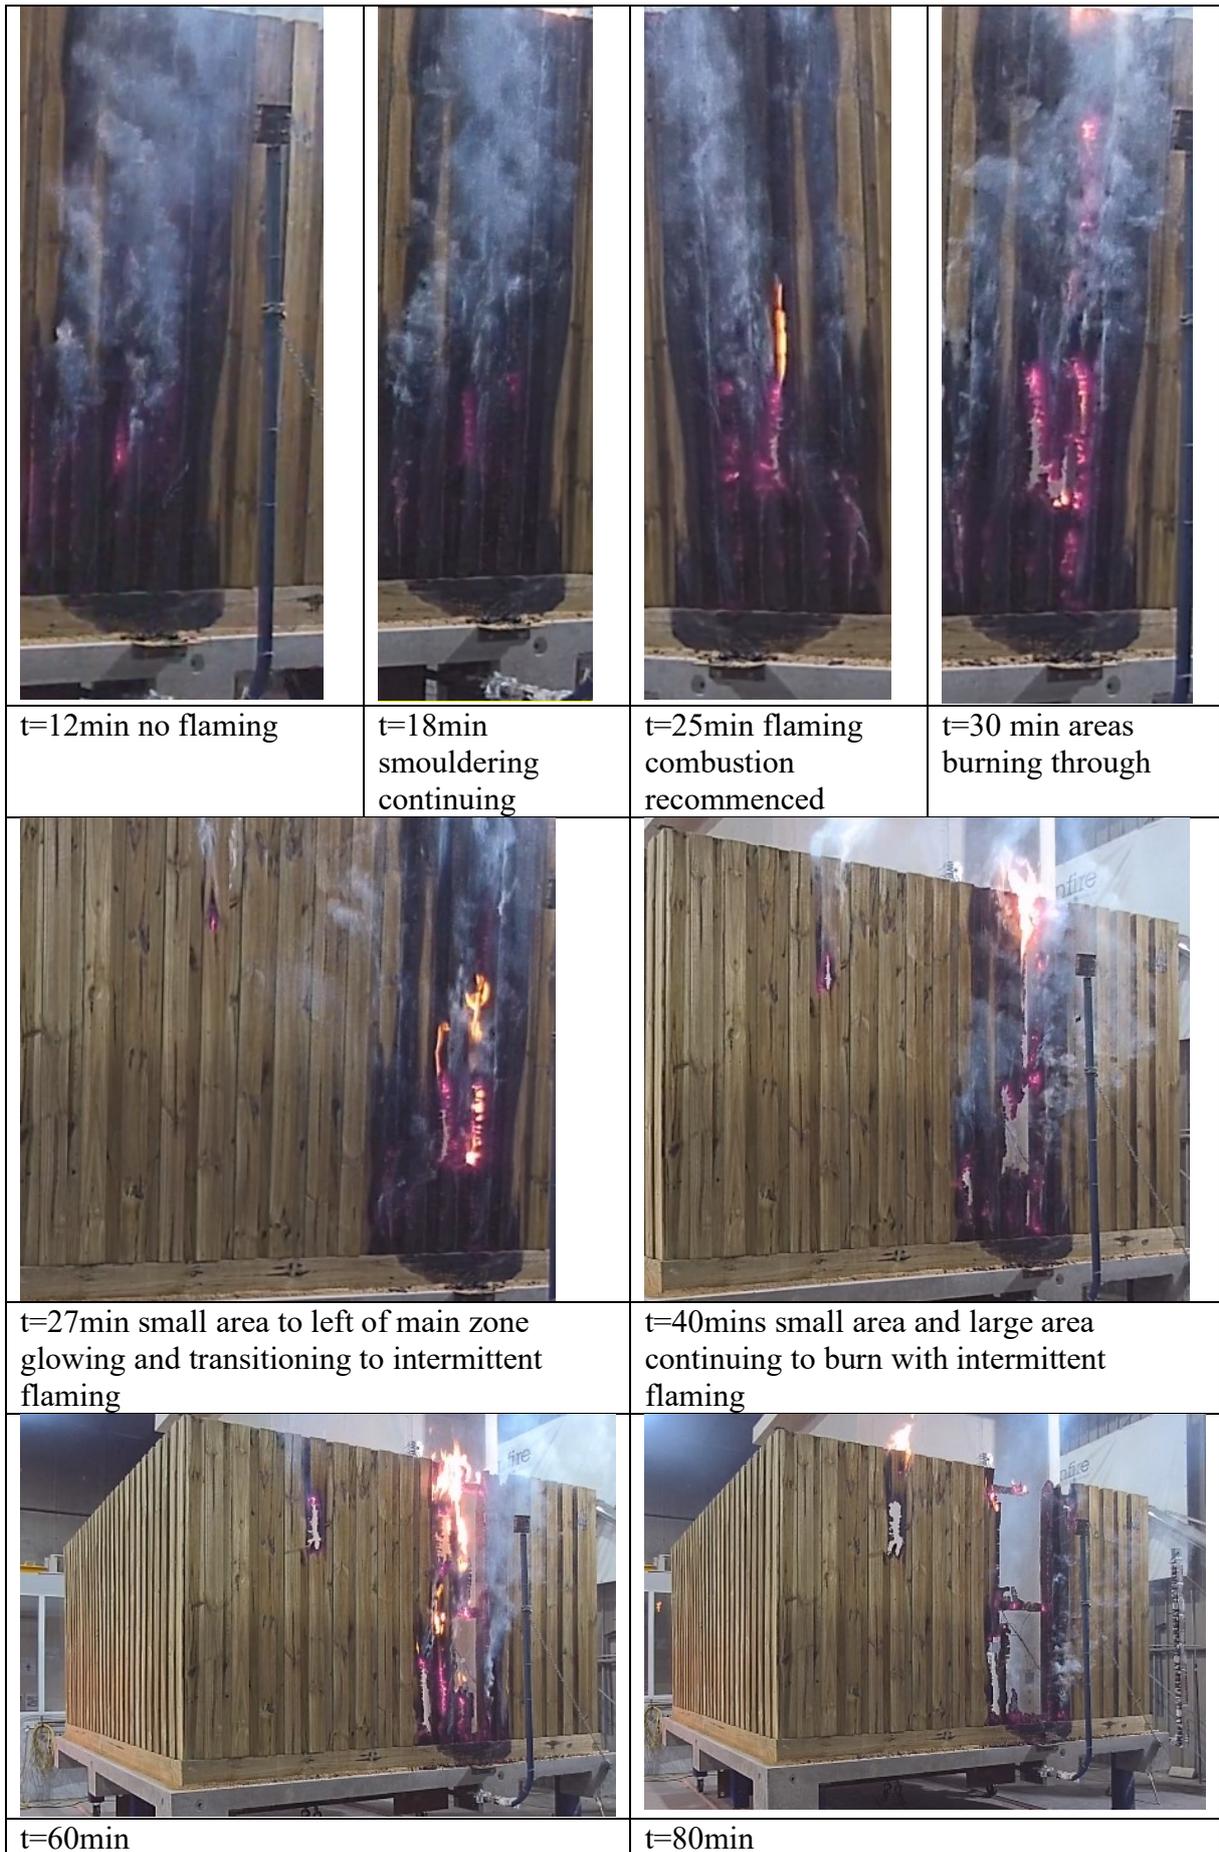
Figure 39 Localised continuing combustion to 80 minutes

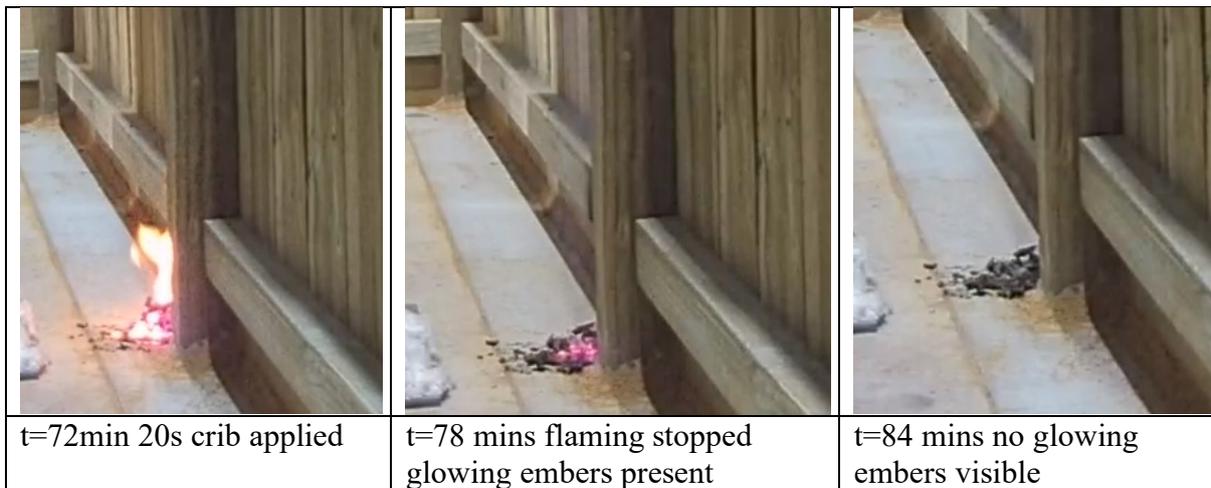
Figure 41 Application of crib to northern fence

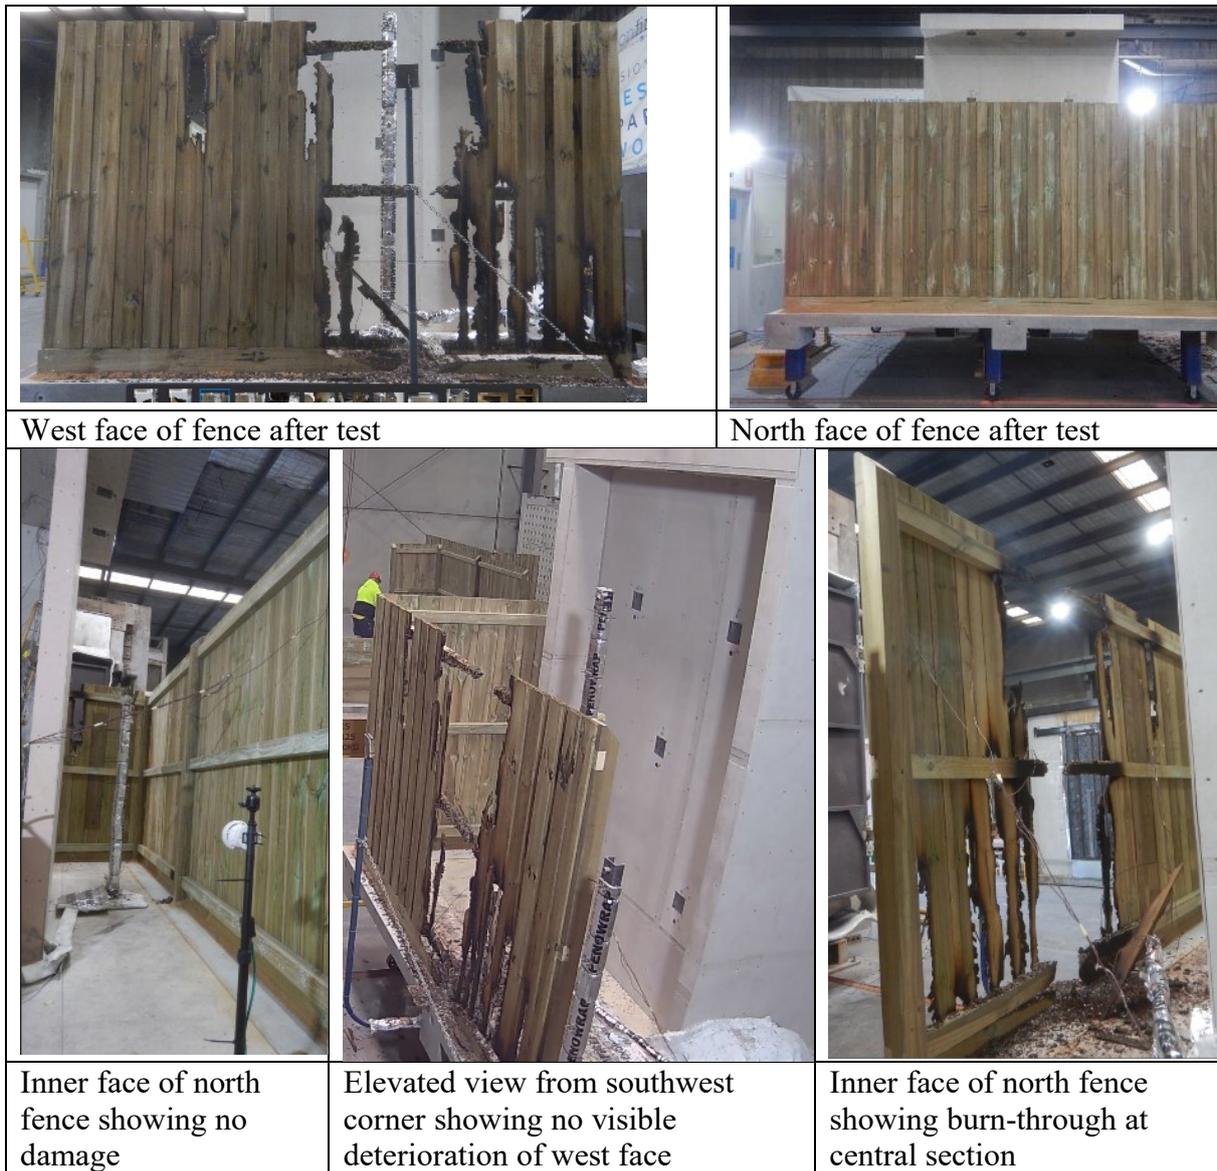
Figure 43 View of specimen after test.

The results are summarised in Table 29. The performance criteria for BAL-12.5 buildings were not exceeded and there was a large margin of safety. Therefore, it is reasonable to expect that the fire load imposed by radiata pine fences similar to those subjected to the test treated with waterborne copper-based preservatives would be unlikely to exceed the design capacity for a BAL-12.5 building if the fence is located within an area classified as BAL-12.5 or less.

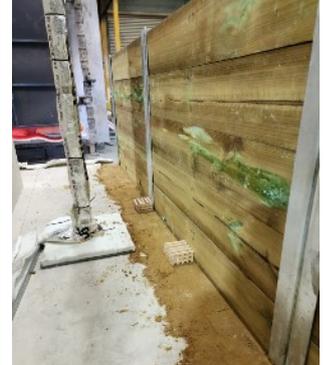
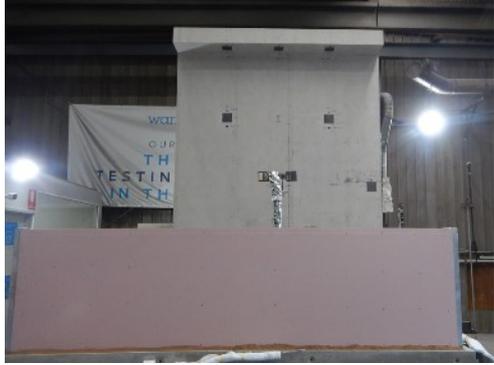
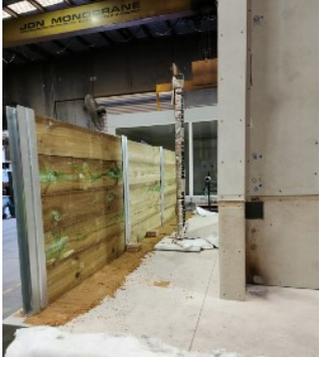
Figure 44 Wall configuration before test

<p>Sleeper wall viewed from east end looking towards simulated fire source</p>	<p>Wall viewed from north. Plasterboard cover in place simulating back filled part of garden bed raised above ground level. Exposed sleepers were facing the north face of the subject building.</p>	<p>Sleeper wall viewed from west looking away from the simulated fire source with west face of reference building visible to the right.</p>

The general sleeper wall configuration before test is shown in Figure 44 and Figure 45 and the test configuration during exposure to the radiant heat profile is shown in Figure 45. In this configuration the west face of the subject building was fully exposed to the radiant heat source and the west face would be expected to exceed the performance criteria for BAL–12.5

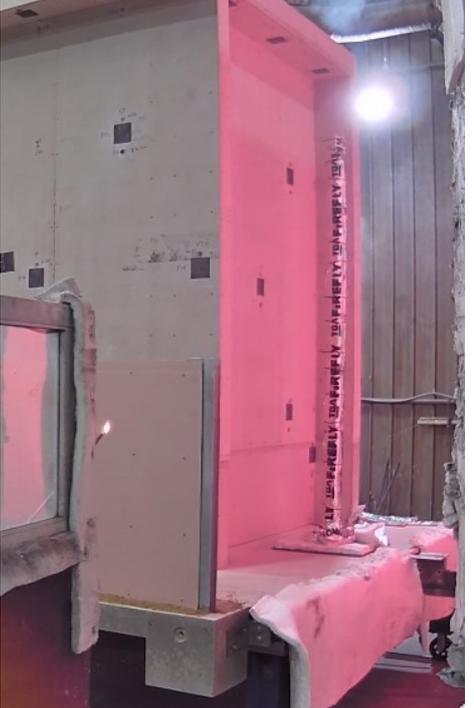
<p>Test configuration viewed from south with the subject building on the right and test wall on the right extending past the subject building. On the left is the heat source</p>	<p>Test configuration viewed from the north showing the back face of the specimen with backfill conditions simulated by coverings. The uncovered sleepers directly faced the north face of the reference building</p>
