Final Report
Project NV054

Investigation of Preservative Treated Plantation Timber Fencing and Sleeper Markets in Bushfire Prone Areas

Project No: NIF144-2122 [NV054]

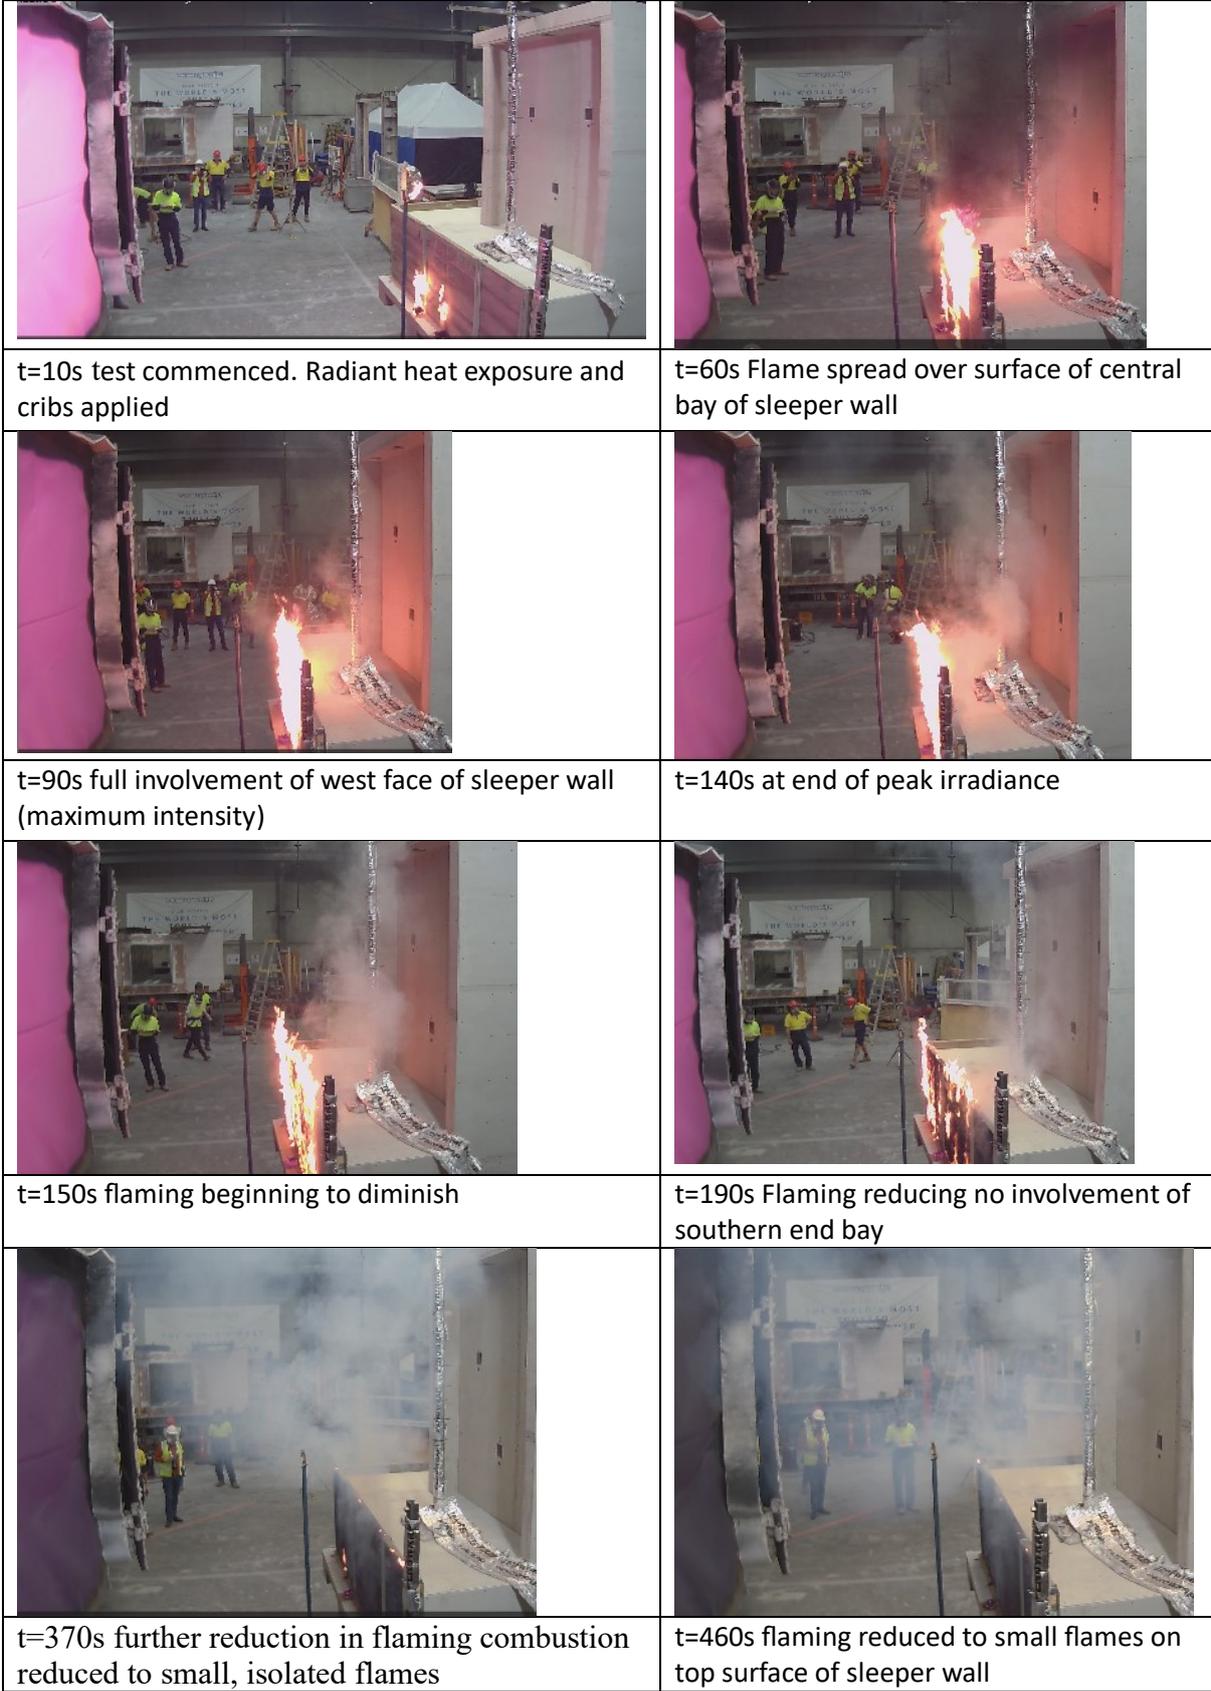
Figure 47 Western sleeper wall exposed to BAL 29 radiant heating profile of AS 1530.8.1

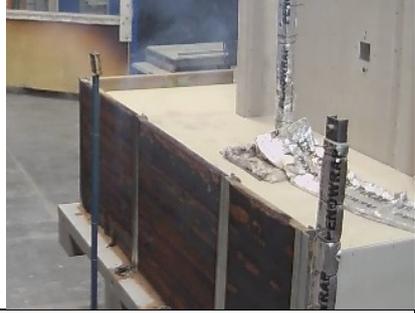
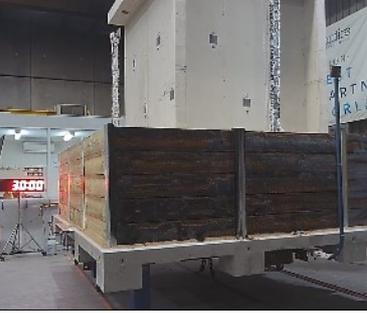
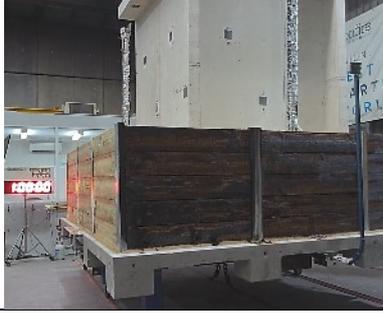
Figure 48 Sleeper wall test 4 from 12 to 60 minutes after heating

t=12 min 20s flaming stopped	t=30 min No flaming visible. Small amounts of smoke from west face indicative of smouldering combustion	t=60 min no appreciable change from 30 minutes

After 12 mins 20s flaming from the west wall had stopped with little visible change at 60 minutes as shown in Figure 48. During the period between 12 minutes and 60 minutes there were traces of smoke released from the central bay indicating the likelihood of sustained smouldering combustion occurring.

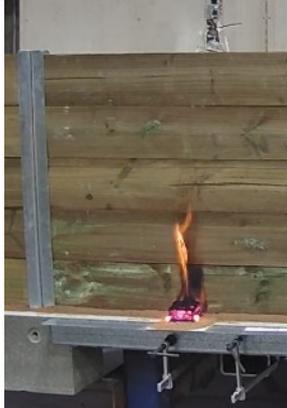
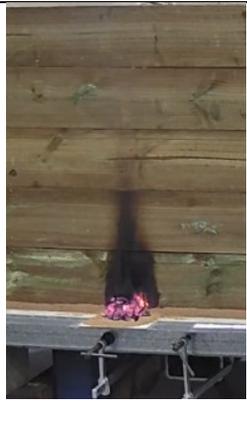
Figure 49 Timber crib test observations from application to northern sleeper wall.

t=72min crib applied to north wall central bay. Smoke release visible from central bay of west wall indicative of smouldering combustion.	t=73min Crib 1 minute after application to north centre bay	t=74min, 2 min after application	t=75min, 3 min after application

t=76min, 4min after application	t=78min, 6min after application	t=80min, 8min after application	t=82min 10min after application	t=92min, 20min after application

An additional burning crib was applied to the north wall 72 minutes after the start of the test to simulate burning embers collecting at the bottom of the wall and potentially igniting the wall. Details of the crib test and reaction of the wall are shown in Figure 49. The sleeper wall self-extinguished after the crib had been fully consumed approximately 10 to 20 minutes after initial application of the crib.

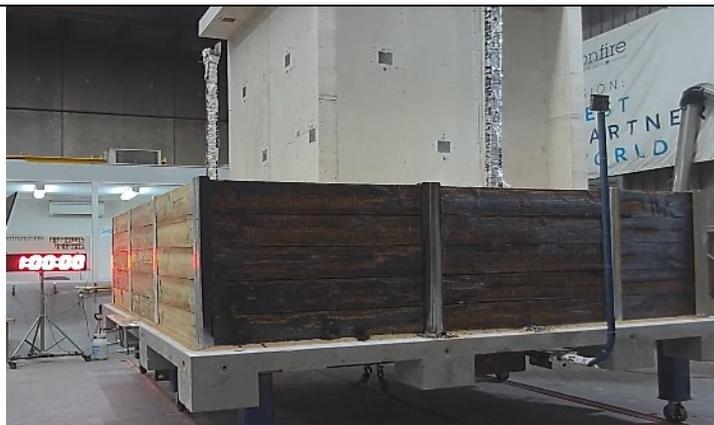
t=2hour
Smouldering
combustion
(no flaming
combustion)

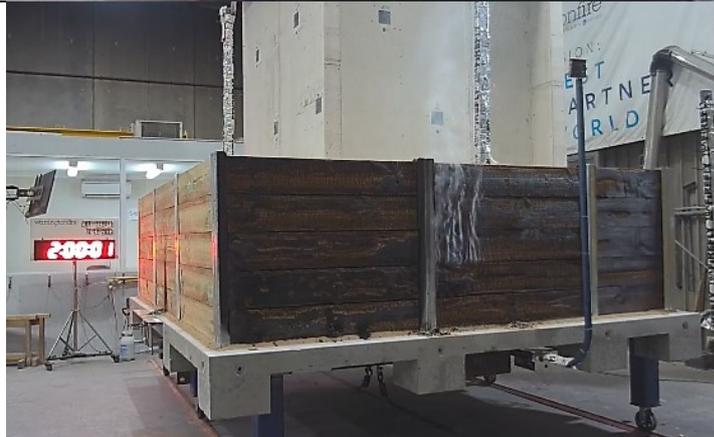
t=2h 40min
Smouldering
and glowing
combustion
(no flaming
combustion)

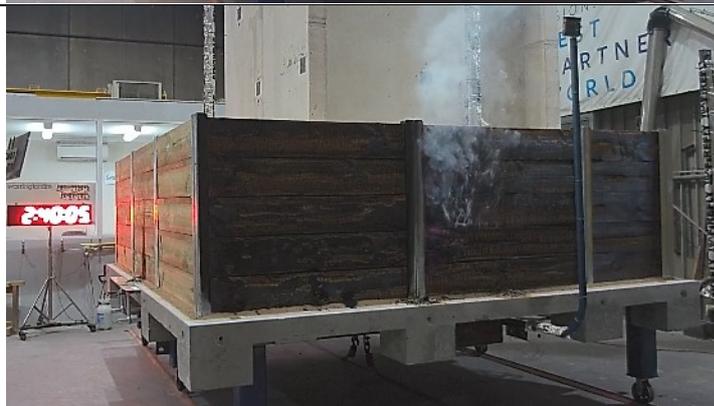
t=2h 41min
flaming
combustion
re-
established
on surface
near source
of smoke

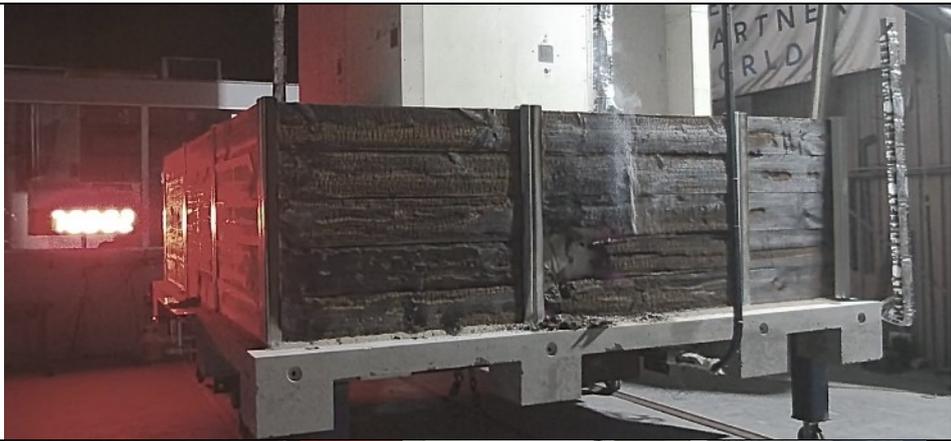
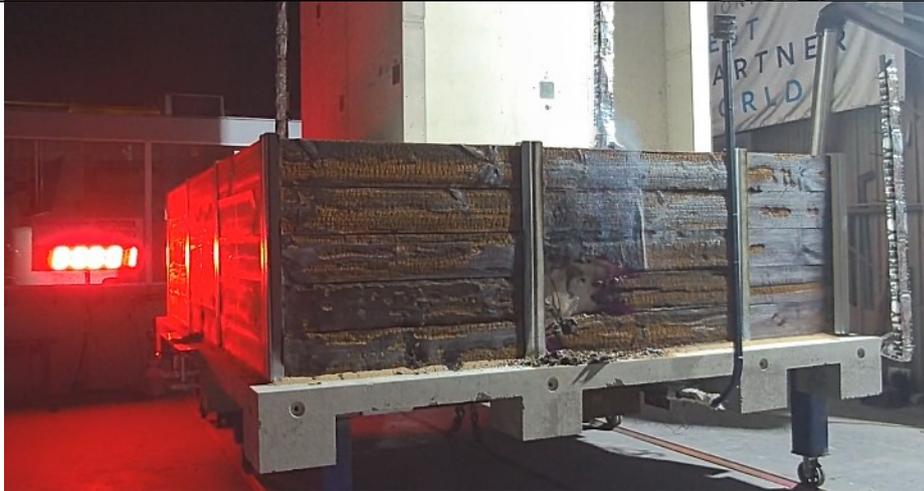
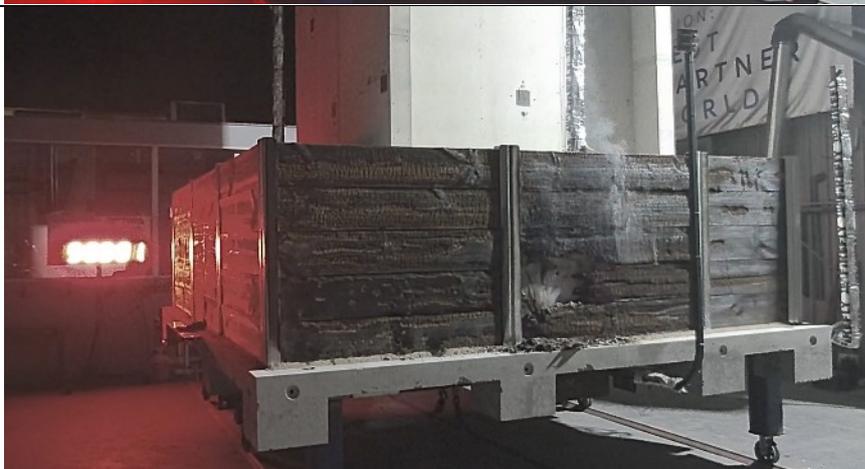
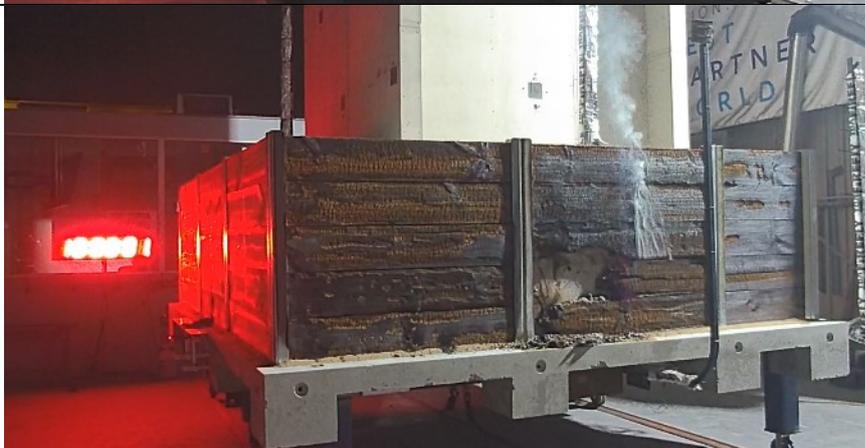
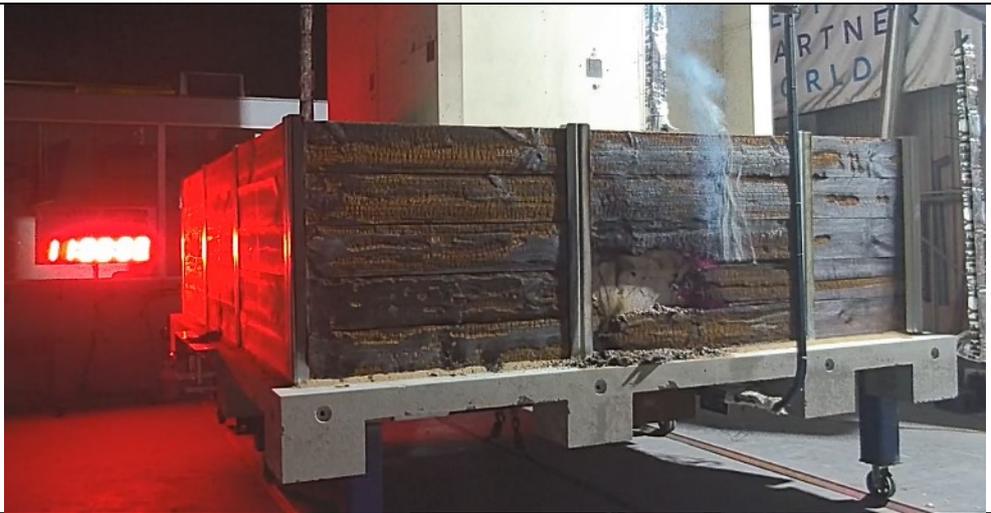
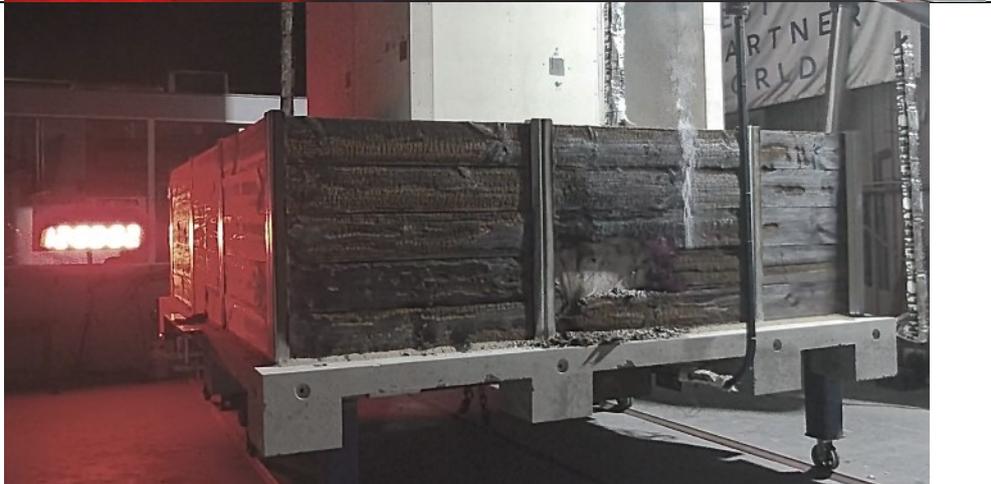
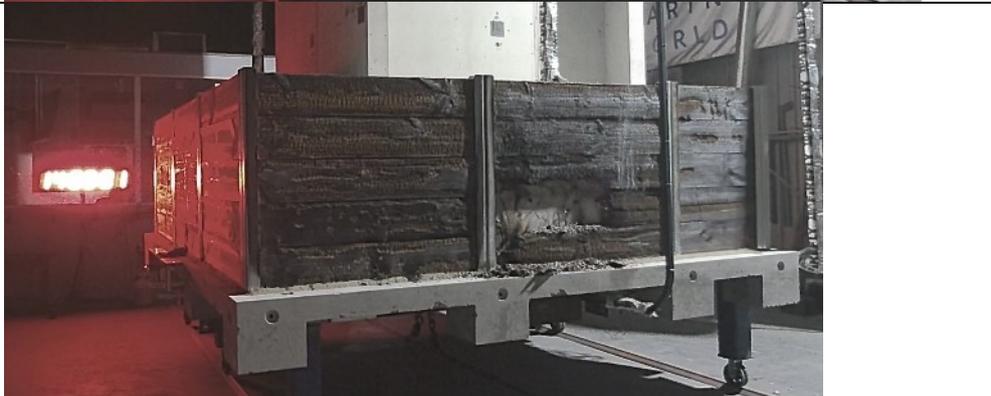
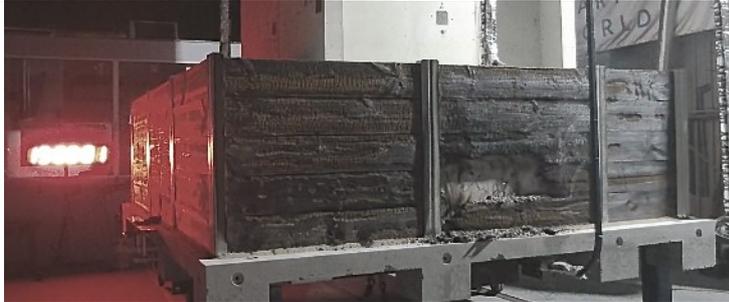
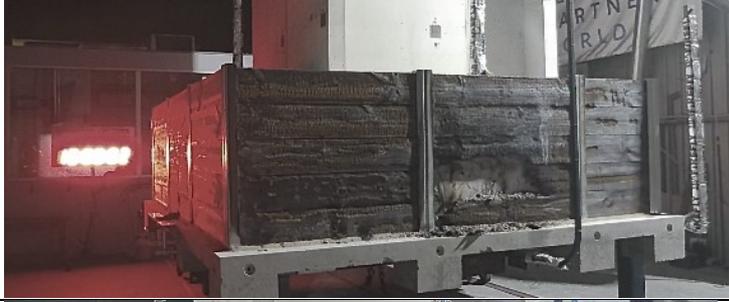
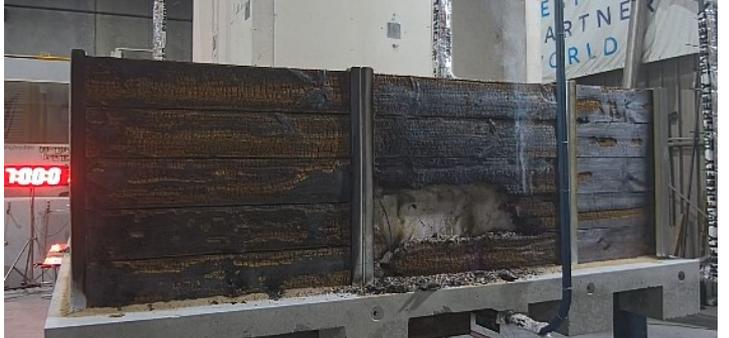
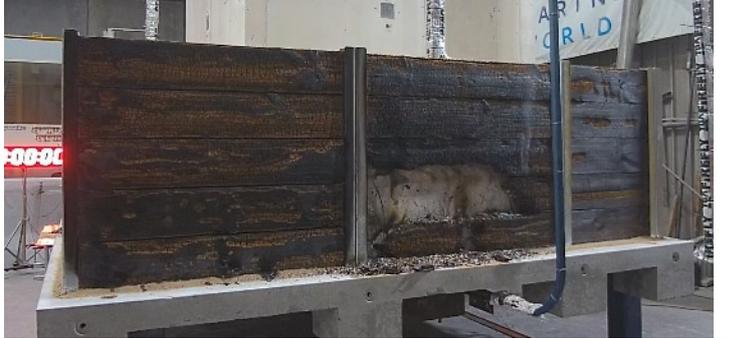
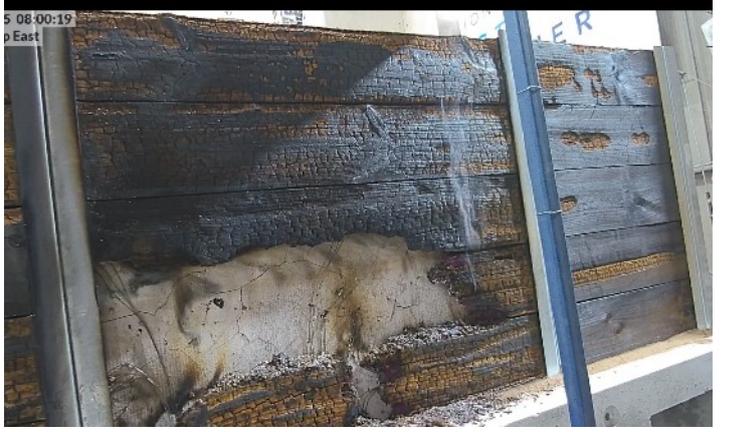
Figure 50 West wall between 1 and 18 hours after the start of the test showing the progressive smouldering combustion of sleepers in the middle bay.

<p>t=18 hours 13min. Showing consumption of the 2nd sleeper and parts of the 1st sleeper & 3rd sleeper at the north end of the central bay.</p>

The specimen was monitored for more than 18 hours after the test. Images are provided in Figure 50 which show sustained smouldering combustion occurring in the central bay on the west wall throughout the 18-hour monitoring period. Re-ignition of flaming combustion occurred at the northern end of middle bay of the west wall after approximately 160 minutes. An image taken after 161minutes is provided in Figure 50 showing the flaming remaining localised. The flaming persisted for over 20 minutes before transitioning to glowing / smouldering combustion. The outer bays on the west wall and the north wall all self-

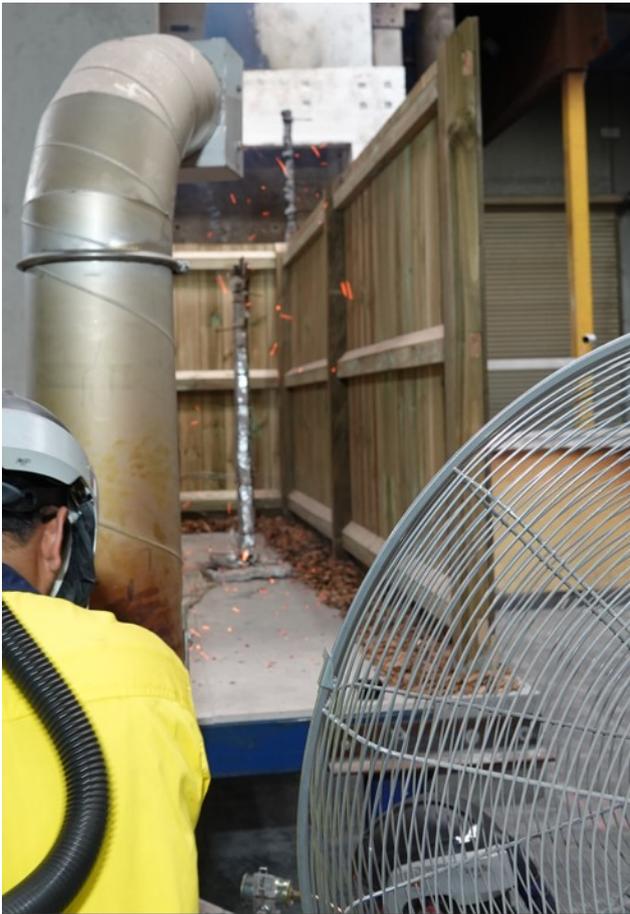
Figure 53 Ember generator and fan during test 1

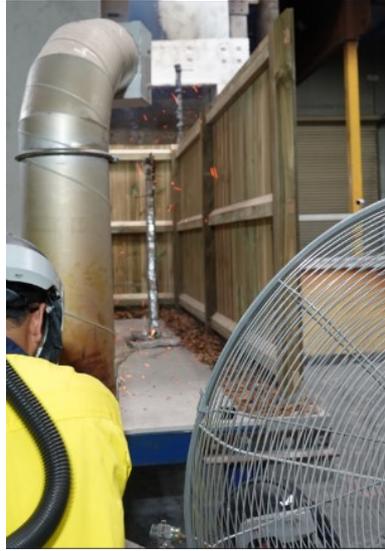
t=4.5 mins. View from east end showing release of embers from ember generator

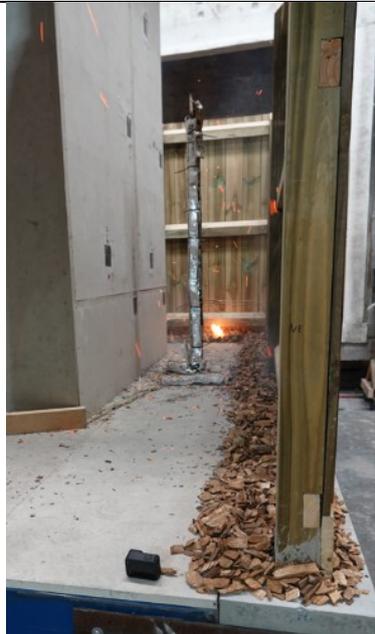
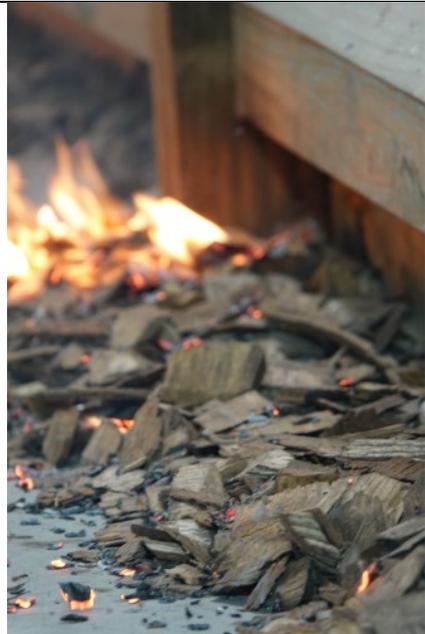
Figure 56 Test observations 4.5 mins to 14.5 mins

t=5 mins. View of NW corner from the south showing embers interacting with mulch

t=10min Mulch at west section of fencing ignited

t=14.5 mulch at mid post north section of fencing ignited

Figure 56 shows the early stages of ember attack and establishment of flaming ignition at two positions prior to 15 minutes exposure. Figure 57 through Figure 59 show progressive fire spread along the fence and consumption initiated by the burning mulch until the test was terminated.

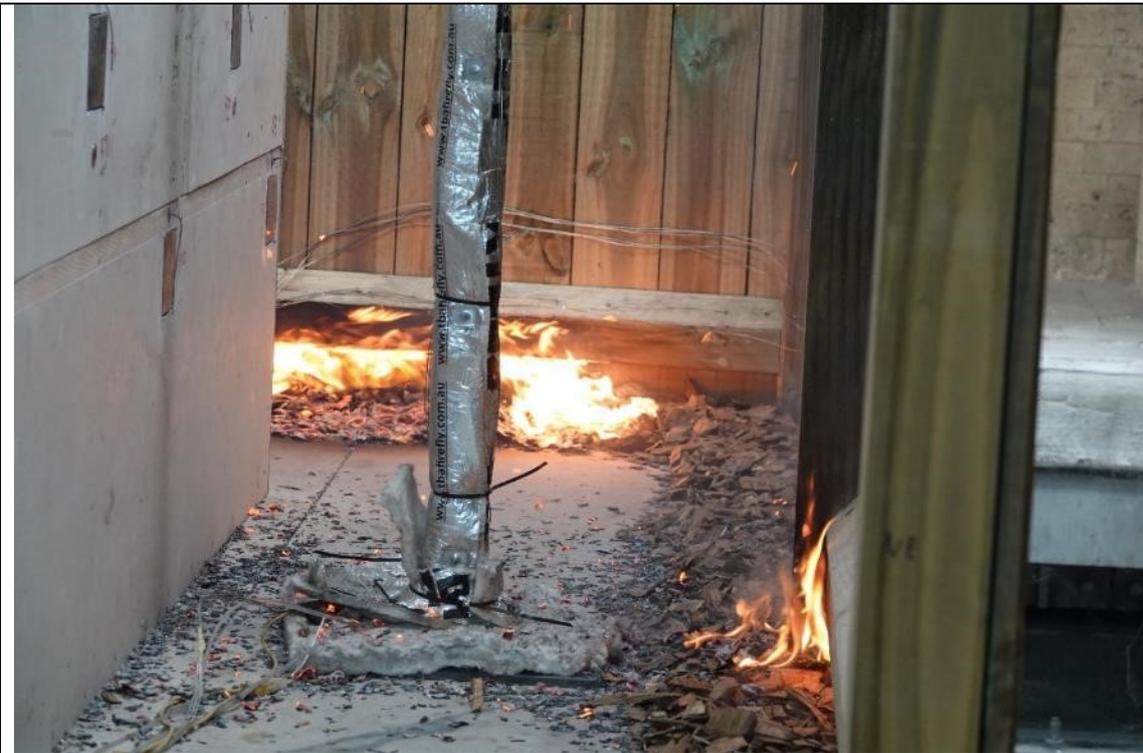
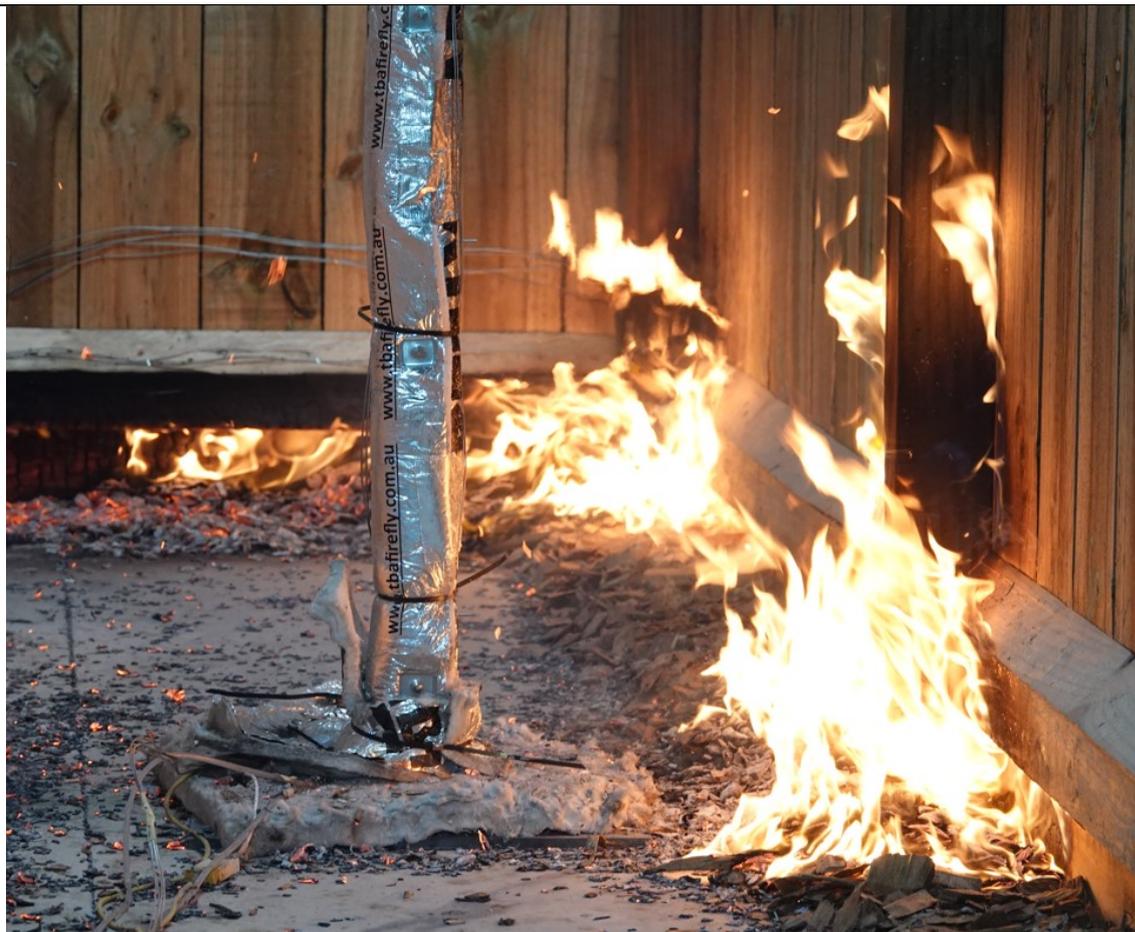
Figure 57 Fire spread from mulch to fencing

t=17.5 mins – background; involvement in flaming combustion of bottom rail of west fence section and right: involvement in flaming combustion of mid post and adjacent rail up to bottom rail

t=21 min–fire spread beyond lower rail at NW corner post and central north intermediate post.

The surface temperatures (refer Figure 60) measured on the corner post indicated that the post was ignited by the burning mulch after approximately 20 minutes which is consistent with the visual observations. This is also consistent with the temperatures measured approximately 100mm from the corner post on the plinth and lower rail (refer Figure 61). The temperatures measured 500mm from the corner post shown in Figure 62 are also consistent with the visual observations (refer Figure 57) confirming spread to the corner post from the south.

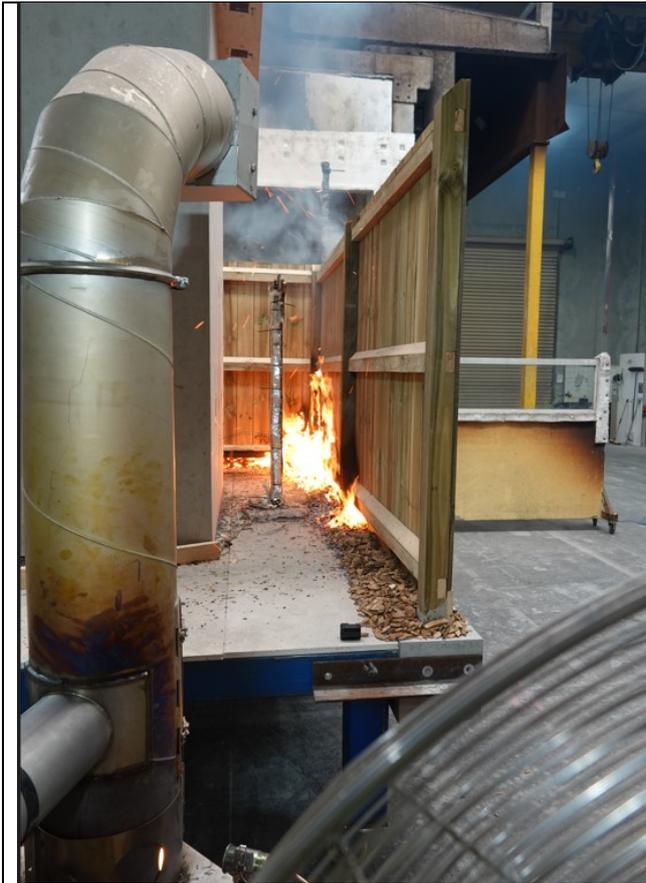
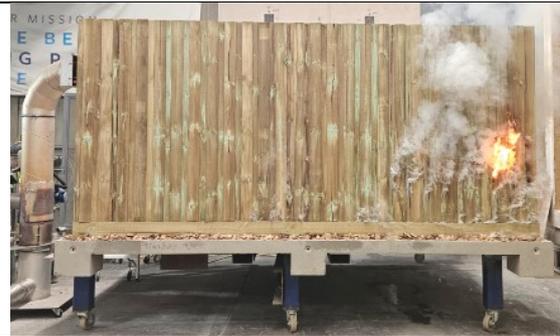
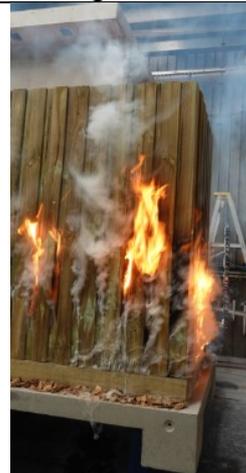
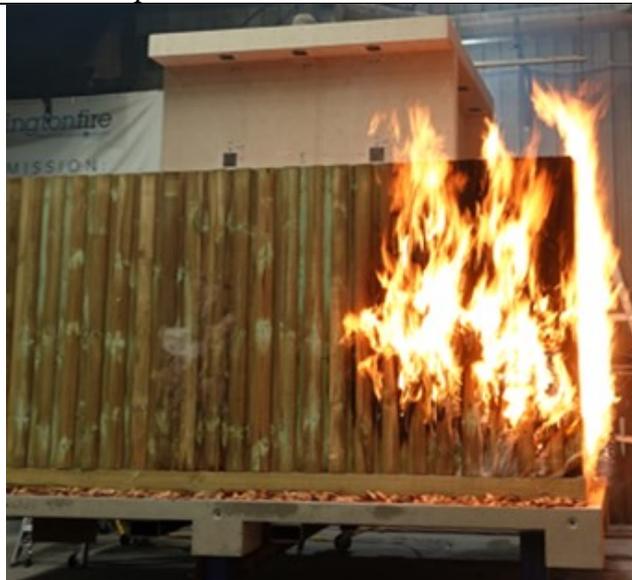
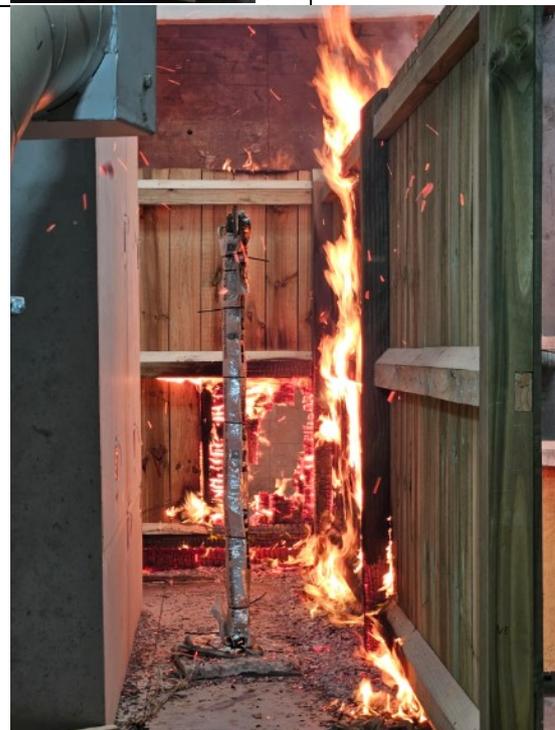
Figure 58 Fire test 1 observations 25-31 minutes

t=25 min Fire development above lower rail west of the central northern fence section post. East of the central northern post there was minimal spread above lower rail

t=25 min Fire spread to outside face of fencing at NW corner

t=26.5 min Fire spread to outside face of fencing at NW corner increasing

t=30 min fire spread over outer surface of face NW corner. Ember generation stopped.

t=31 min Opening developing in lower half of west part of fence

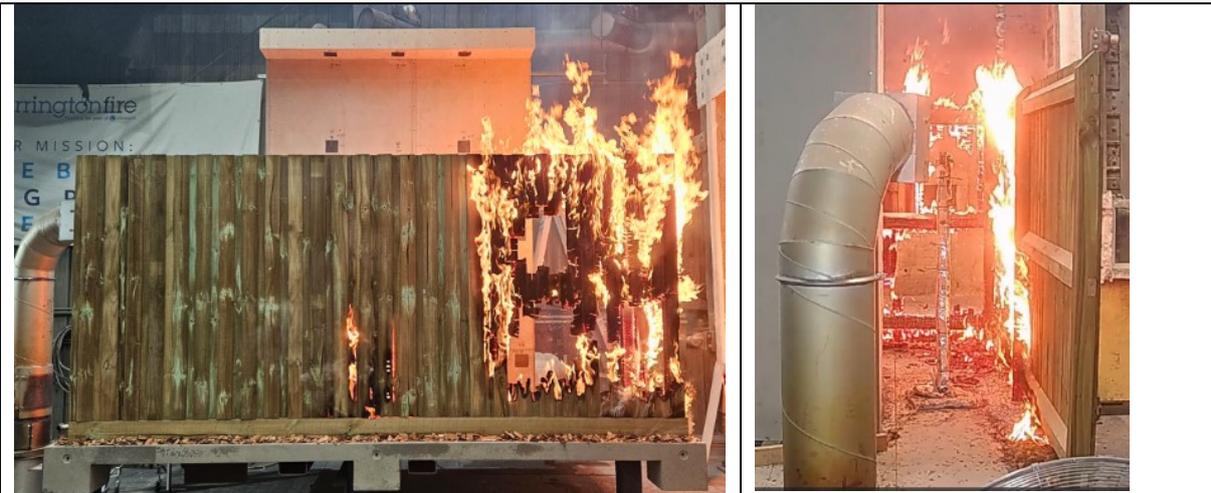
t=34 min fire spread and opening up of west end of north fence with minor burn through by central post

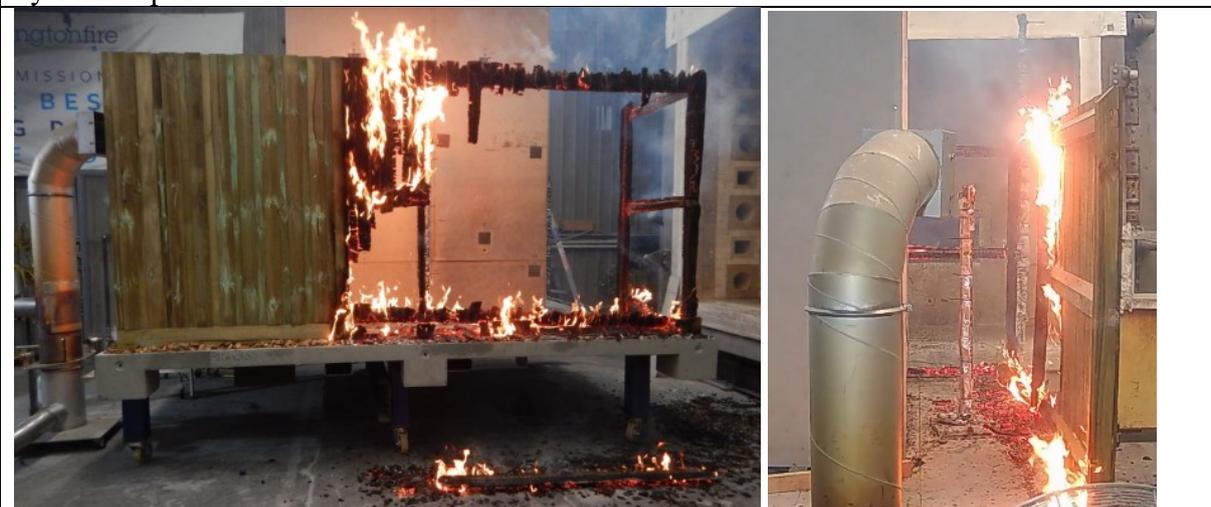
t=50min air flow terminated - palings on west fence and western end of north fence consumed and central rail at western end of north fence fallen away.

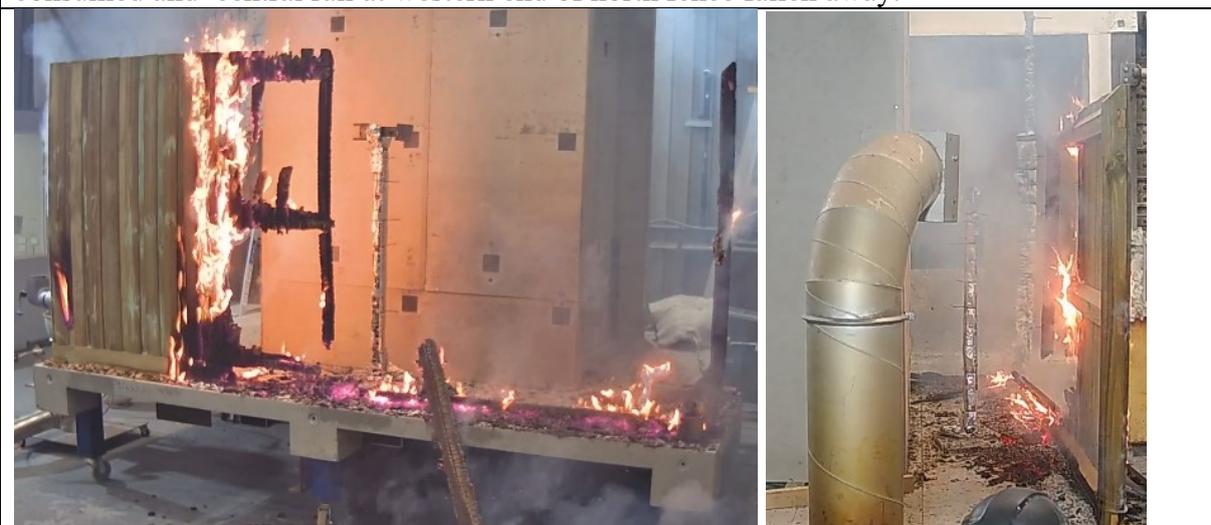
Figure 59 Fire Test 1 Observations 34min to 50 min

t=62min test terminated (note northwest corner post and top and bottom rails on north face of specimen collapsed after approximately 58- 60 minutes exposure

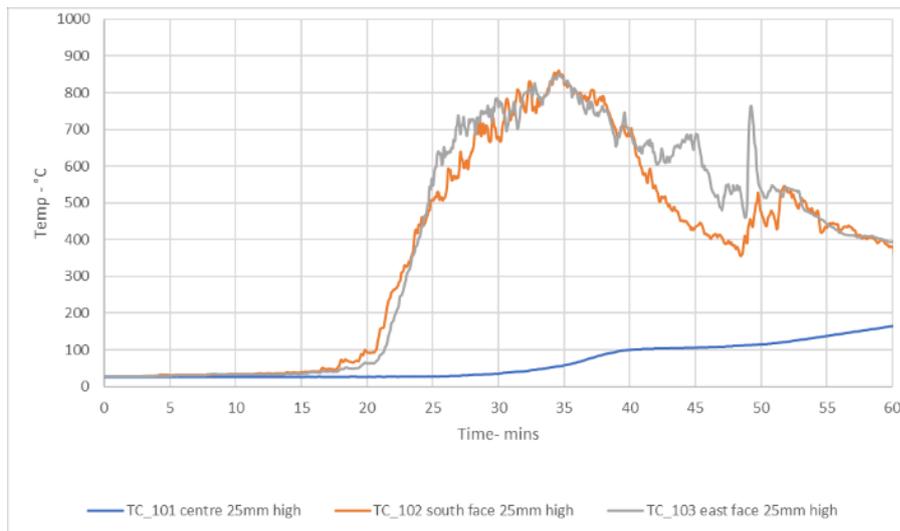
Figure 60 Corner post temperatures for ember test 1: Lapped paling fence with mulch at base of exposed to ember attack with applied airflow

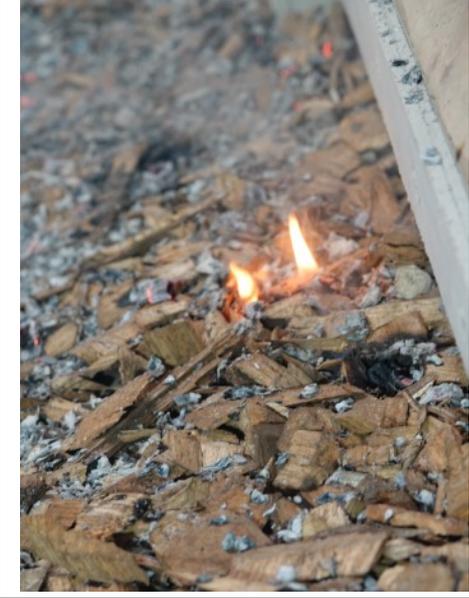
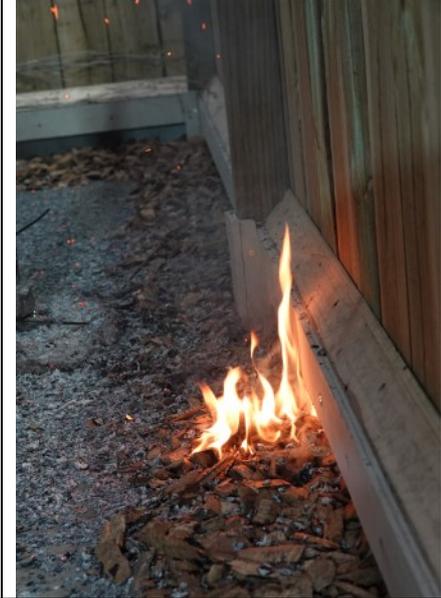
<p>t=22.5 Initial ignitions</p>		<p>t= 26.7 min burning mulch</p>

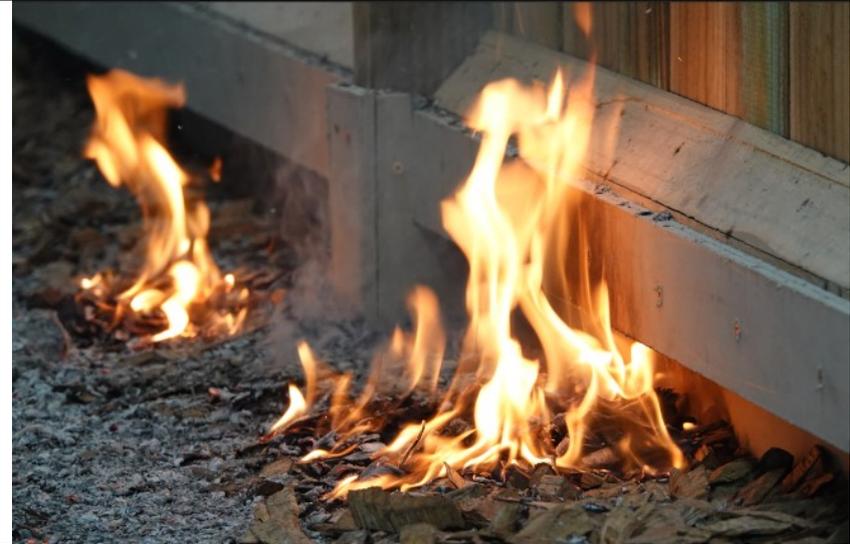
<p>t=30 Established flaming ignitions of mulch – ember generator stopped</p>

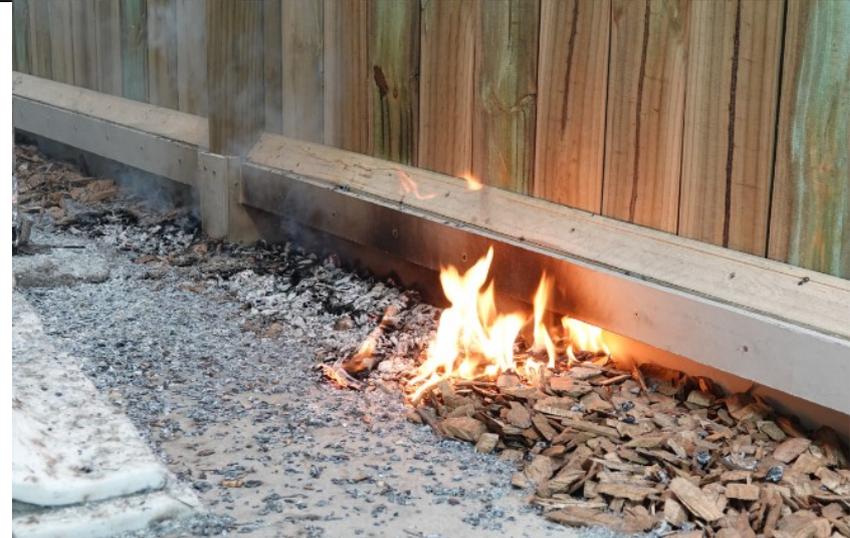
<p>t=44min Mulch being progressively consumed as fire front moves against prevailing air flow but no evidence of sustained combustion of the fence.</p>

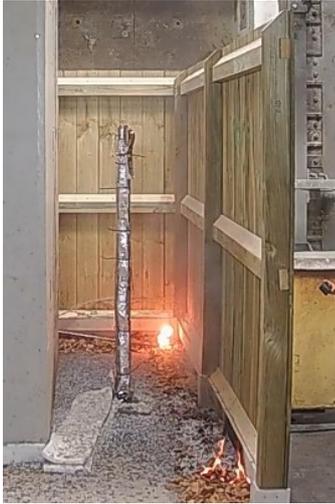
<p>t=62 mins mulch manually ignited near the north-west corner of fence - burning of mulch west of the central post has self-extinguished therefore mulch ignited to investigate performance if the burning mulch fire had spread.</p>

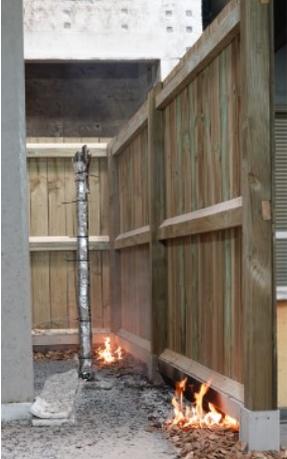
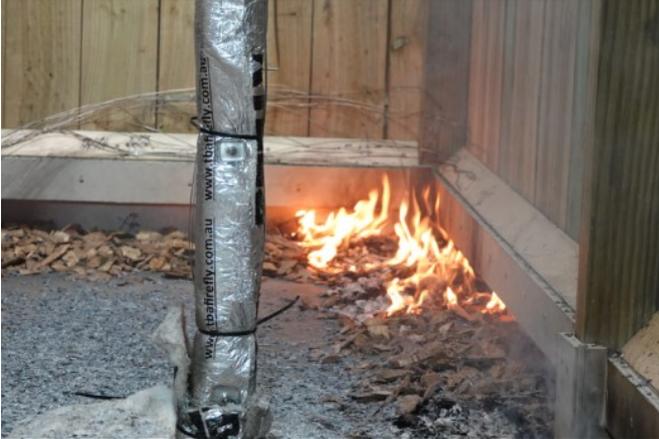
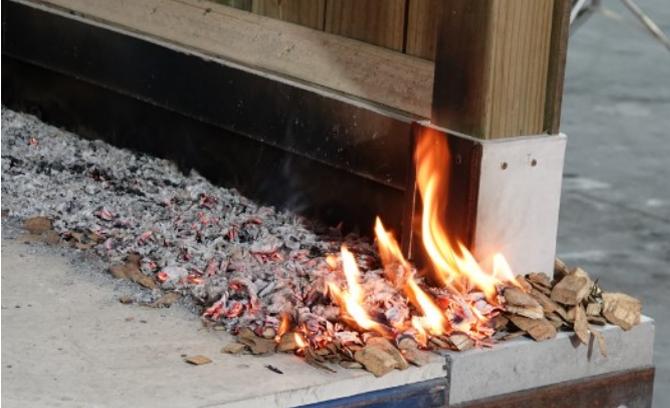
Figure 71 Observations from 62 minutes to 93 minutes after start of test

<p>t=68 mins Mulch fire in north-west corner (background) established and fire in foreground continues spreading along the base of the north fence towards the east end post</p>

<p>t=73 min Mulch fire in NW corner</p>

<p>t=93 min mulch fire front spread to east post along base of north wall</p>

Figure 70 shows ember attack and establishment of flaming ignition at two positions during the 30 minutes exposure. The mulch was progressively consumed as fire front in the mulch bed moved in an easterly direction against prevailing air flow. Figure 71 shows the piloted ignition of the mulch close to the north-east corner post after approximately 62 minutes, and

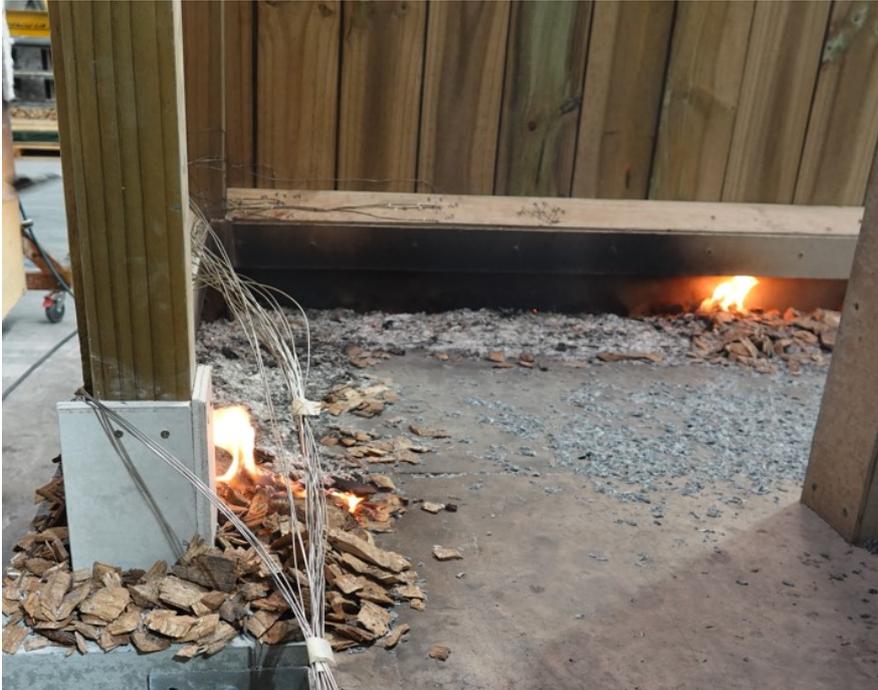
Figure 72 $t=112\text{min}$ fire spread from NW Corner along west and north fences approximately 1m with no ignition of timber fencing.

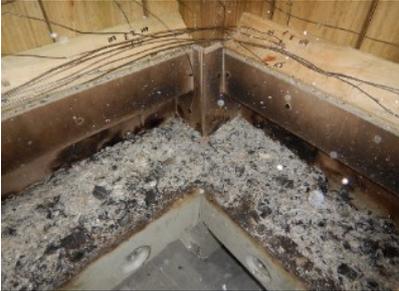
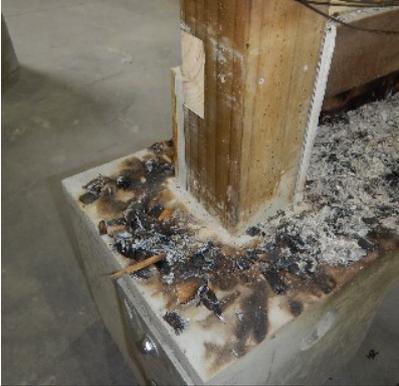
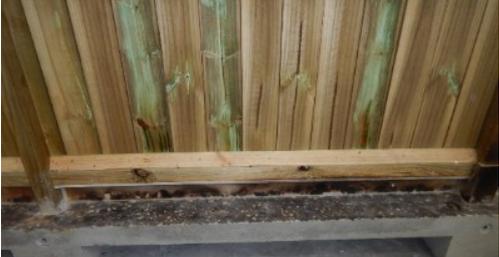
Figure 73 Fence 14h after test . Mulch had burnout without igniting the fence

<p>North -west corner with residual ash from embers and mulch after test</p>

<p>End of western fence section with residual ash from embers and mulch and minimal damage to timber post</p>

<p>Eastern end of north fence with protection to face of lower rail and left hand post removed showing minimal damage to timber</p>

Figure 73 shows the fence after test and monitoring for a total of 14 hours. There was minimal damage to the fence timber elements.

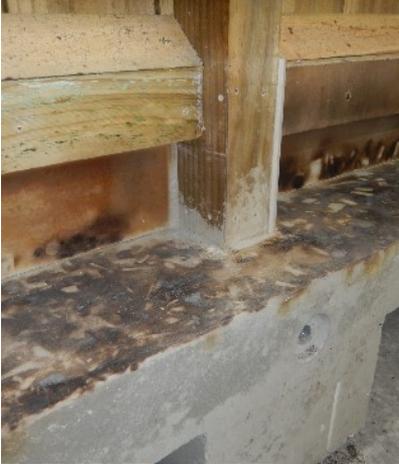
<p>Post at centre of north fence with protective coverings to face of lower rail and post in the foreground removed showing minimal impact on timber post and rail.</p>

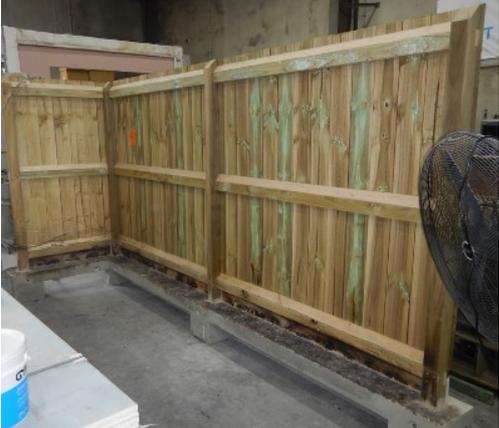
<p>Face of fencing that faced the simulated building with protection removed showing minimal damage to timber.</p>

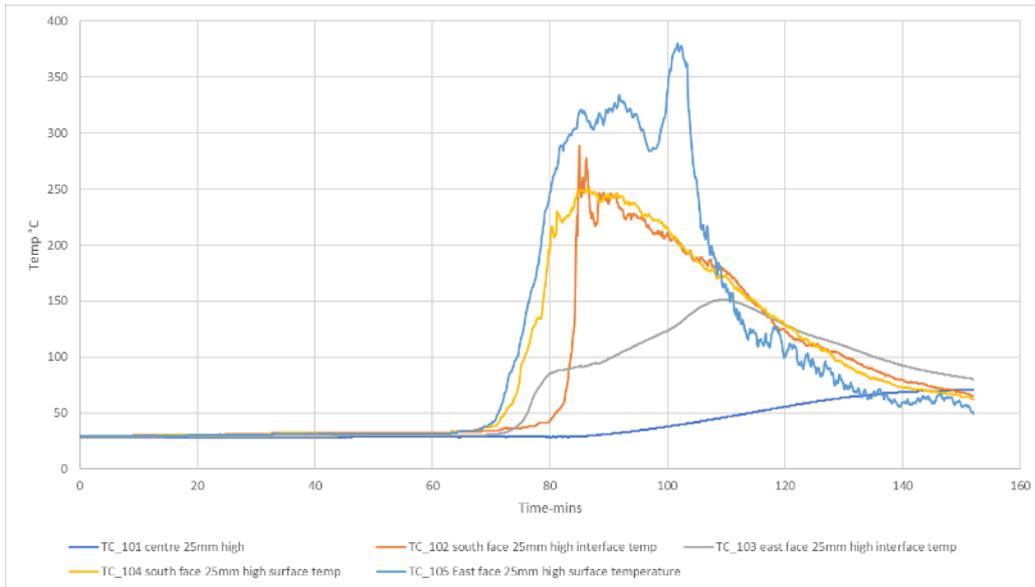
Note TC-102 temperature is similar to exposed surface temperature and may have malfunctioned
 Figure 74 Corner post temperatures for ember test 2: Lapped paling fence with ground level protection

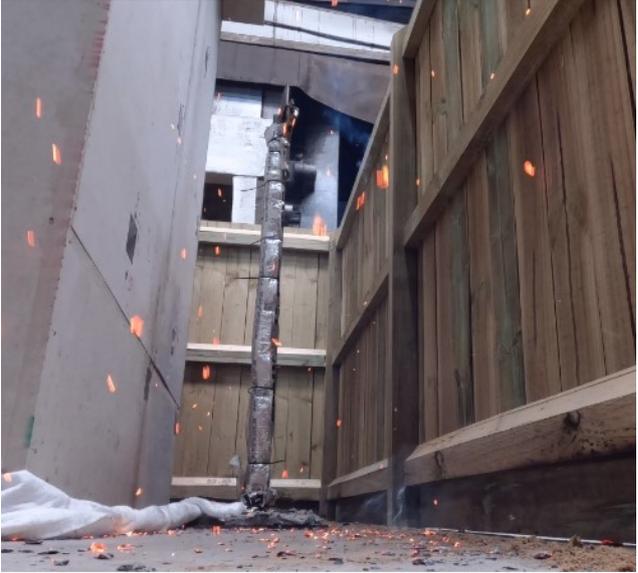
<p>t = 1 minute ember attack showing embers deflected away from fence rails by 45° section fitted to rails and collecting on the floor</p>

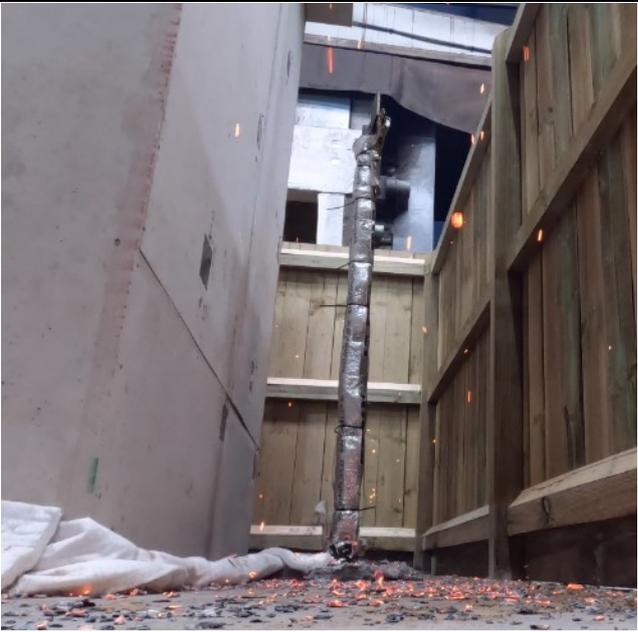
<p>t = 5 minute ember attack</p>

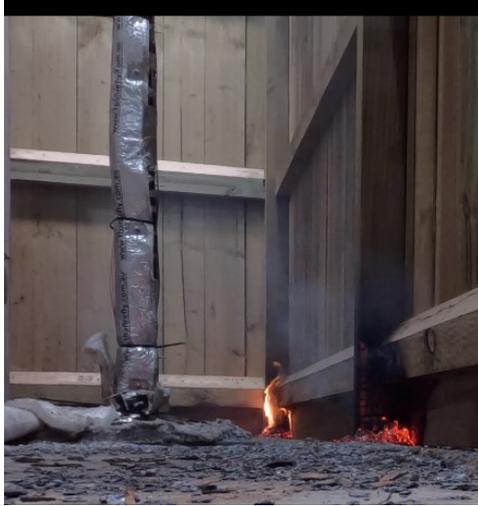
Crib 1 transitioning from flaming to smouldering combustion 42 minutes 50s after commencement of data logging - slight evidence of smouldering combustion from fence post. Flaming of crib 2 continuing at a reduced level
