Final Report
Project NV054

Investigation of Preservative Treated Plantation Timber Fencing and Sleeper Markets in Bushfire Prone Areas

Project No: NIF144-2122 [NV054]

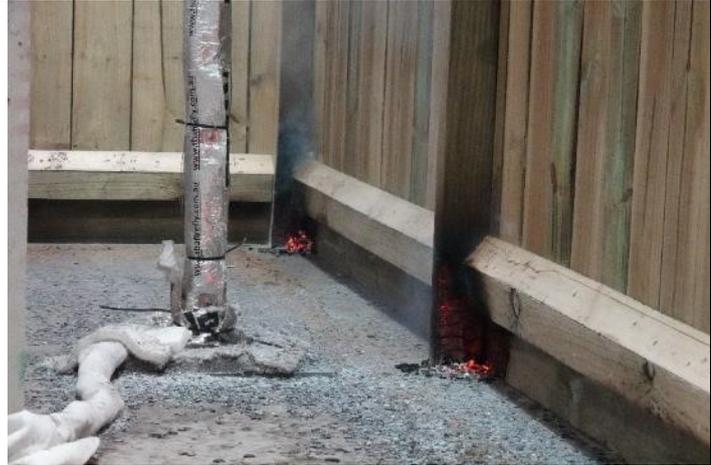
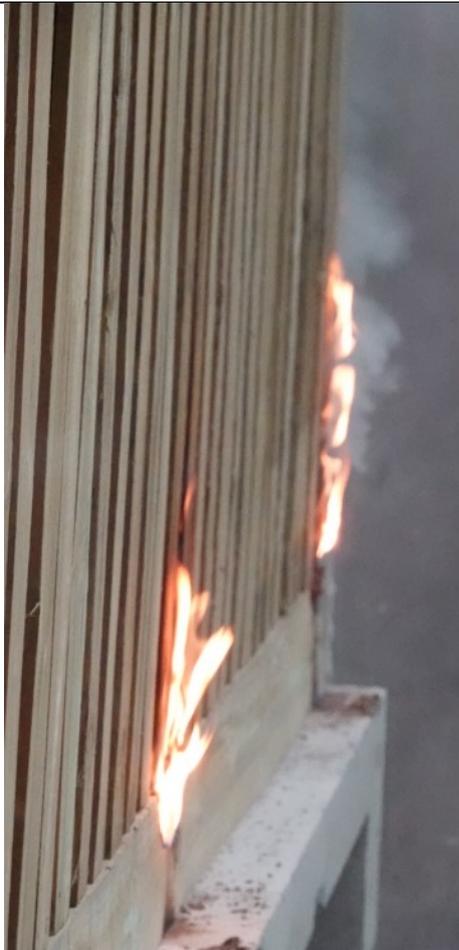
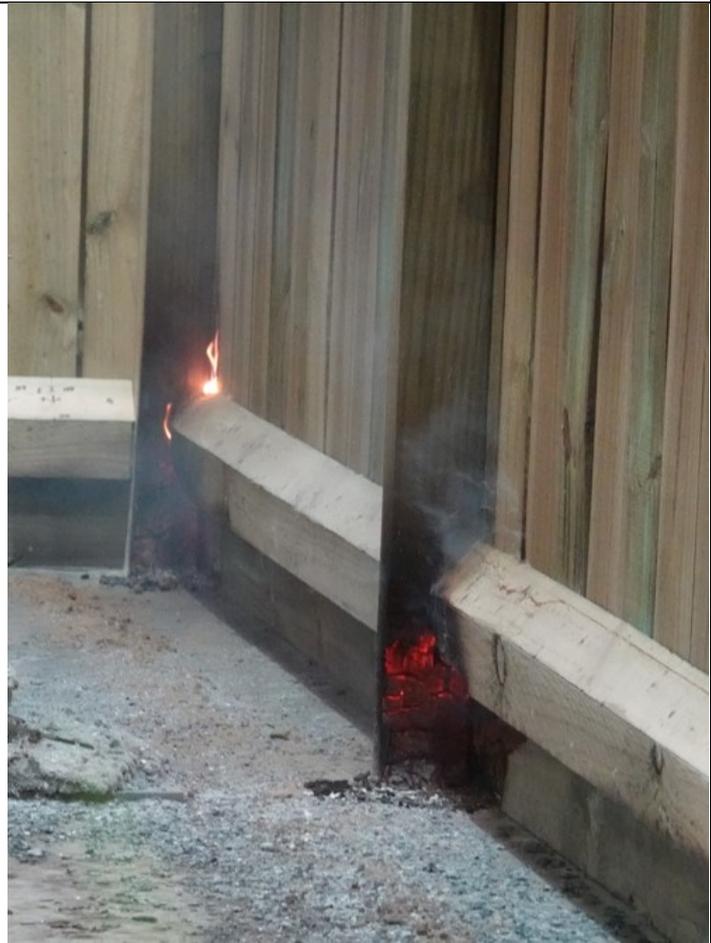
Figure 82 Transition to smouldering combustion of the crib and fencing materials in close proximity to the crib and later transition to flaming combustion of fencing materials

Crib 1 transitioning from flaming to smouldering combustion 42 minutes 50s after commencement of data logging - slight evidence of smouldering combustion from fence post. Flaming of crib 2 continuing at a reduced level

Smouldering combustion of cribs and posts 51 minutes after commencement of data logging

Flames breaking through to outer face of fence after 82mins 30seconds

Flaming and smouldering combustion at base of columns after 83mins

After application of the flaming cribs, the flames lapped the lower rail as shown in Figure 81 but as the timber cribs were consumed, they tended to transition to smouldering combustion and also initiated smouldering combustion of the posts and palings as shown in Figure 82.

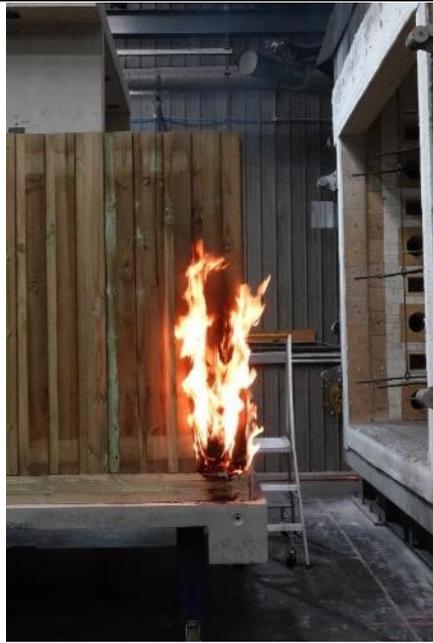
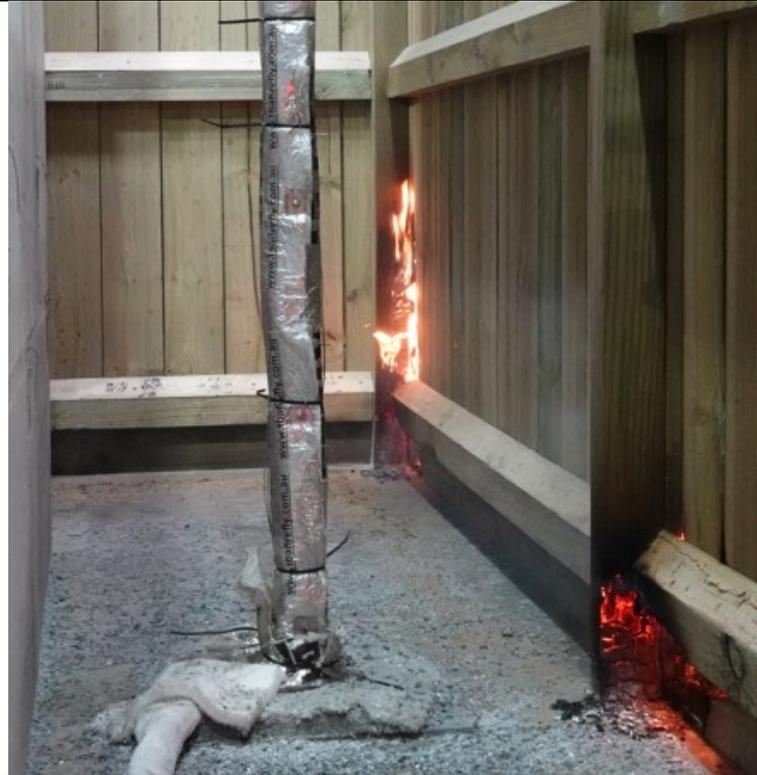
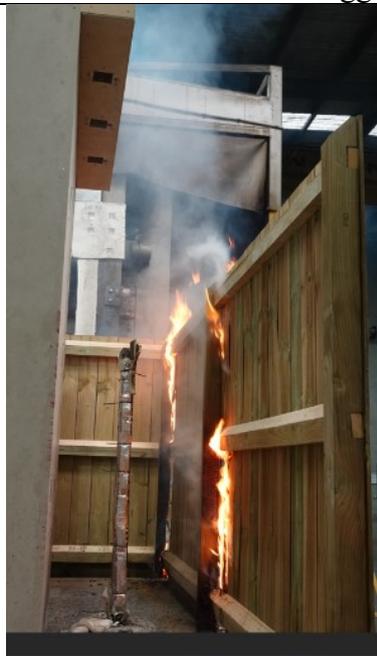
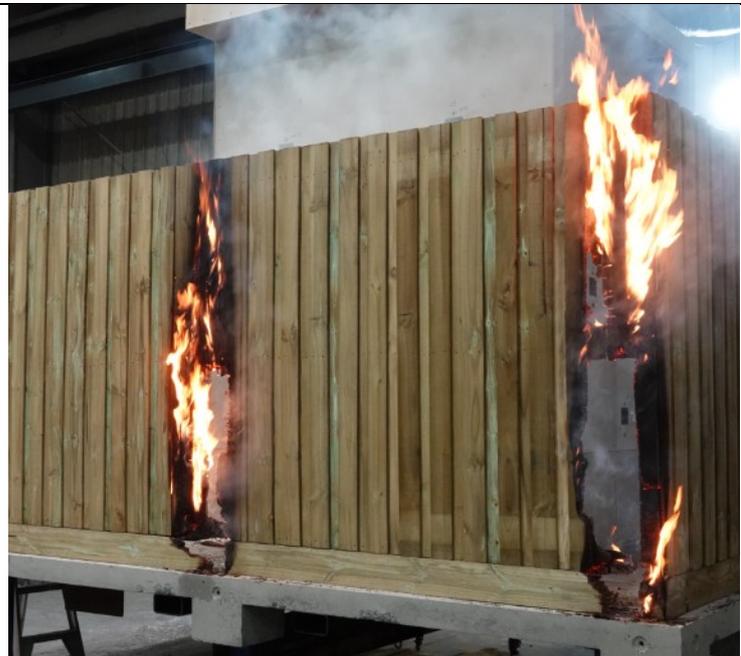
Figure 83 Growth of flaming combustion of the fencings

Flaming on outer face of northwest corner approximately 86 minutes 30 seconds after commencement of data logging

Transition to flaming of posts at interface with palings on side facing simulated building, approximately 87 minutes after commencement of data logging

Flaming on side of fence facing the simulated building approx. 106 minutes after commencement of data logging

Flaming on outer face of fence approx. 106 minutes after commencement of data logging

Flaming combustion developed more rapidly on the outer face than the inner face between 82 minutes and 106 minutes (refer Figure 83) but fire spread slowed with the burning areas remaining localised until the end of the test after 120 minutes and subsequent suppression. Suppression required only a light water spray. The specimen after test and after suppression is shown in Figure 84.

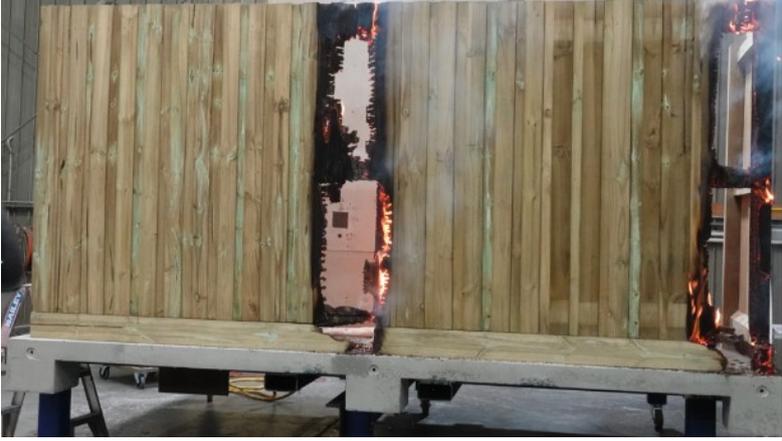
<p>Outer face of fence after 120 minutes – test terminated</p>	<p>Fence facing simulated building at end of 120 minute test.</p>

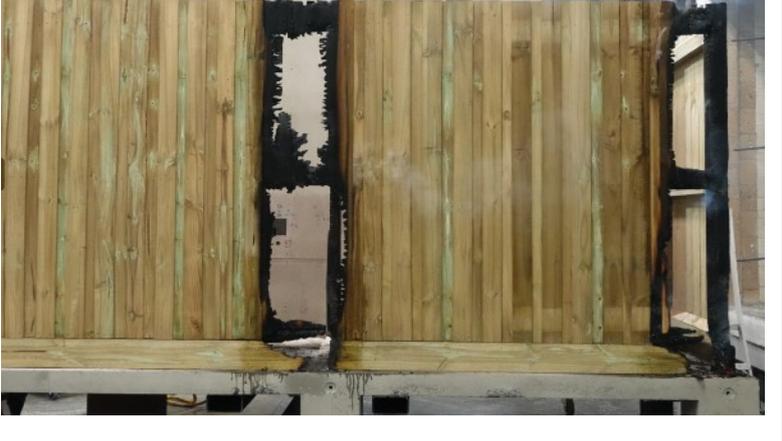
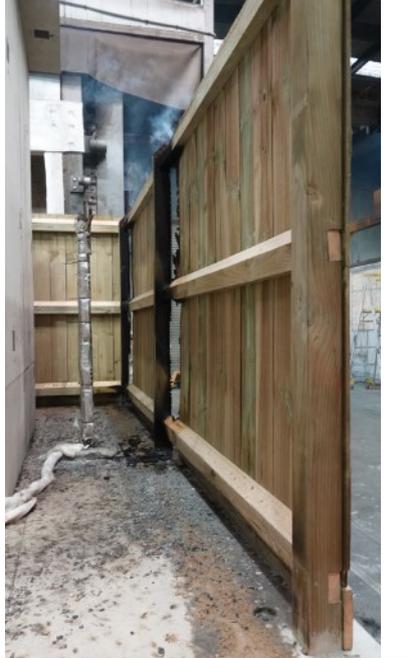
Figure 84 Fencing at the end of test and after suppression after test was completed.

<p>Outer face of fence after extinguishing residual combustion</p>	<p>Fence facing simulated building after extinguishing residual combustion</p>

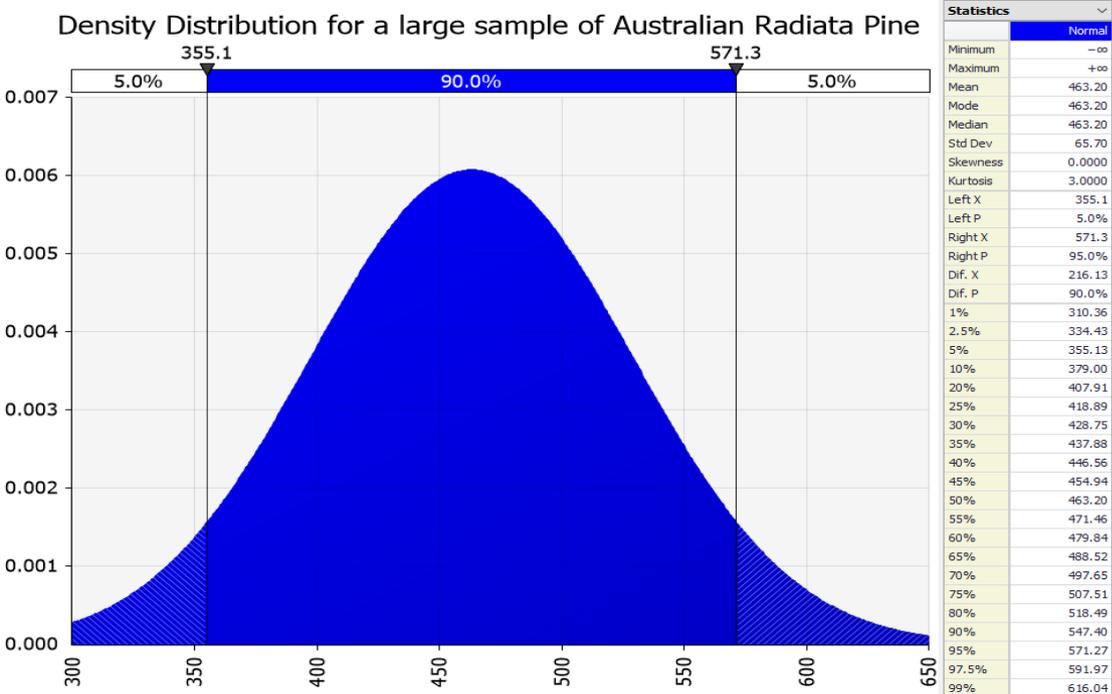
Figure 1 Density Distribution from a large sample of Australian Radiata Pine (Morrell 2022)

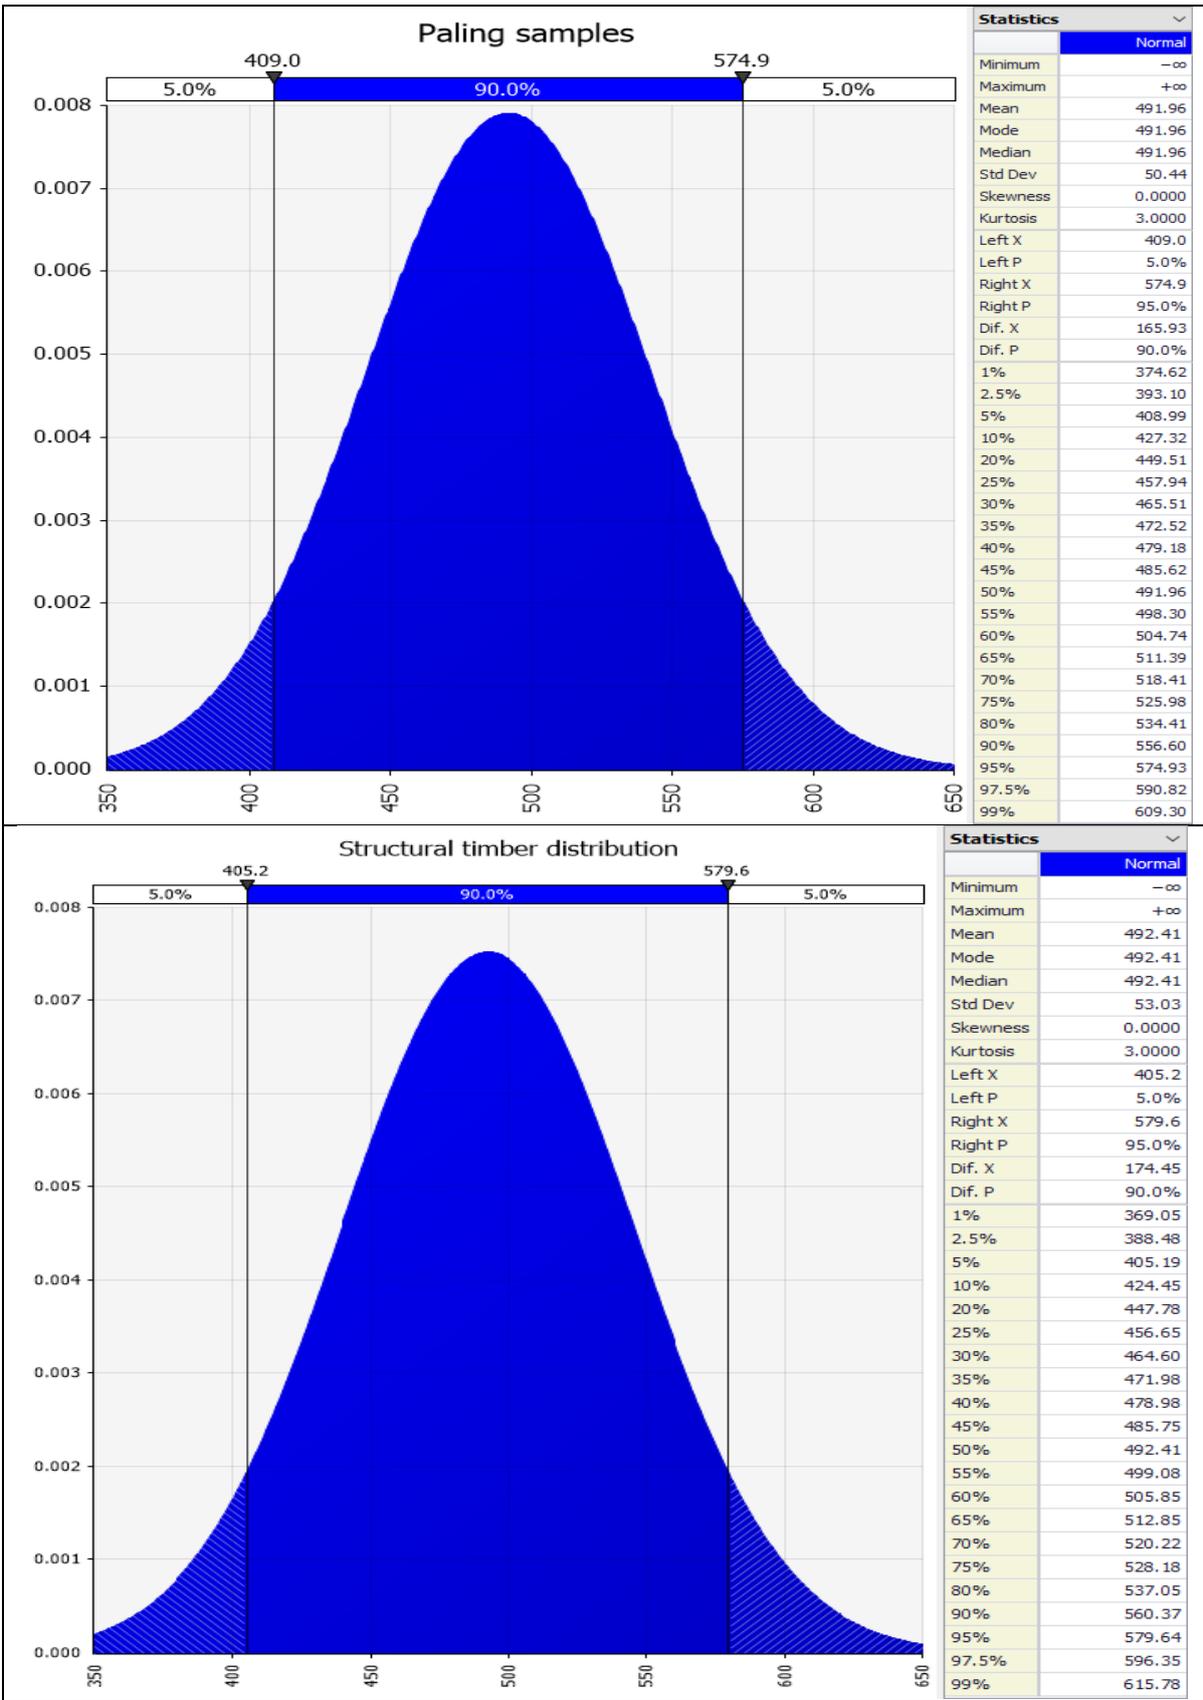
Figure 2 Distribution of densities for samples of Radiata Pine subjected to Cone calorimeter tests

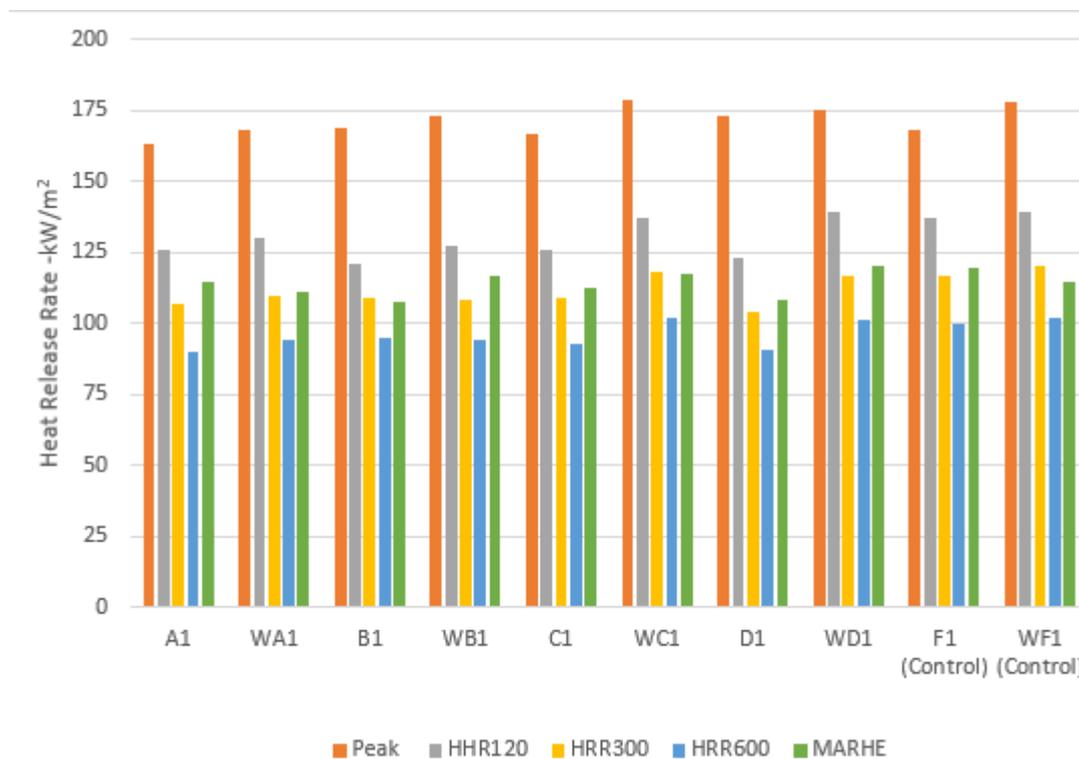
Figure 5 Comparison of HRR data for all specimens of nominal 41mm thickness, exposed to 50kW/m² irradiance

Specimen	T _{ig} (s)	Peak HRR (kW/m ²)	HRR ₁₂₀ (kW/m ²)	HRR ₃₀₀ (kW/m ²)	HRR ₆₀₀ (kW/m ²)	MARHE (kW/m ²)	Density (kg/m ³)
A1	13	163	126	107	90	114.6	469
WA1	19	168	130	110	94	111.3	466
B1	14	169	121	109	95	107.6	488
WB1	11	173	127	108	94	116.6	439
C1	12	167	126	109	93	112.7	433
WC1	21	179	137	118	102	117.4	475
D1	15	173	123	104	91	108.1	469
WD1	19	175	139	117	101	120.5	435
F1 (Control)	16	168	137	117	100	119.7	503
WF1 (Control)	25	178	139	120	102	114.6	531
G1 (Acrylic P)	12	184	129	114	102	117	557
Mean	16	172	130	112	97	114.6	479
Max	25	184	139	120	102	120.5	557
Min	11	163	121	104	90	107.6	433
S.D	4.2	6	6	5	4	4.1	38

T_{ig} – Time to ignition, HRR-Heat Release Rate, HRR_n – HRR averaged over n seconds after ignition, MARHE – maximum average rate of heat of emission, SD standard deviation

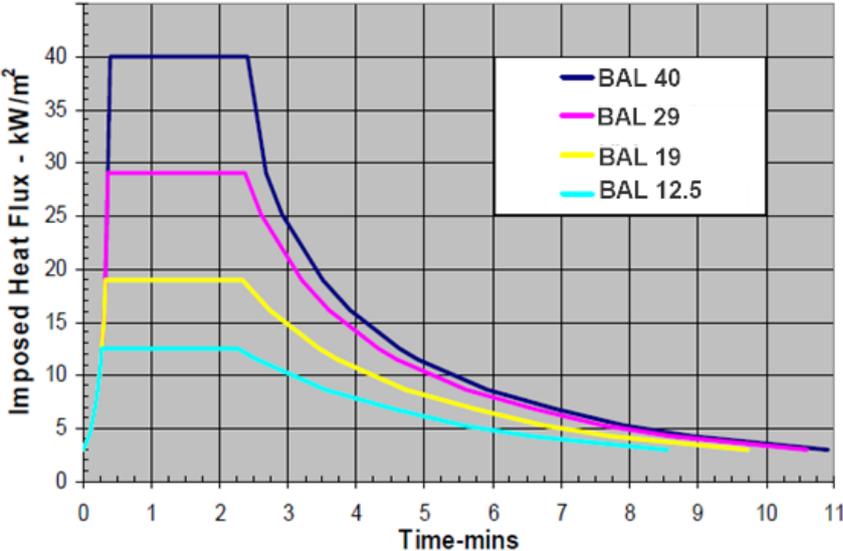
Figure 12 AS1530.8.1 Radiant Heat Profiles based on AS 1530.8.1

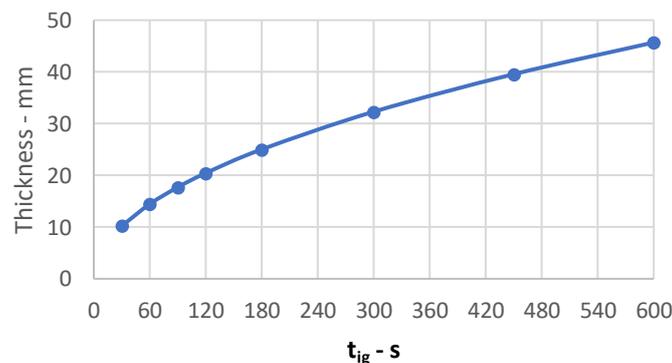
Figure 13 Bounding condition for thermally thick materials based on thickness and time to ignition

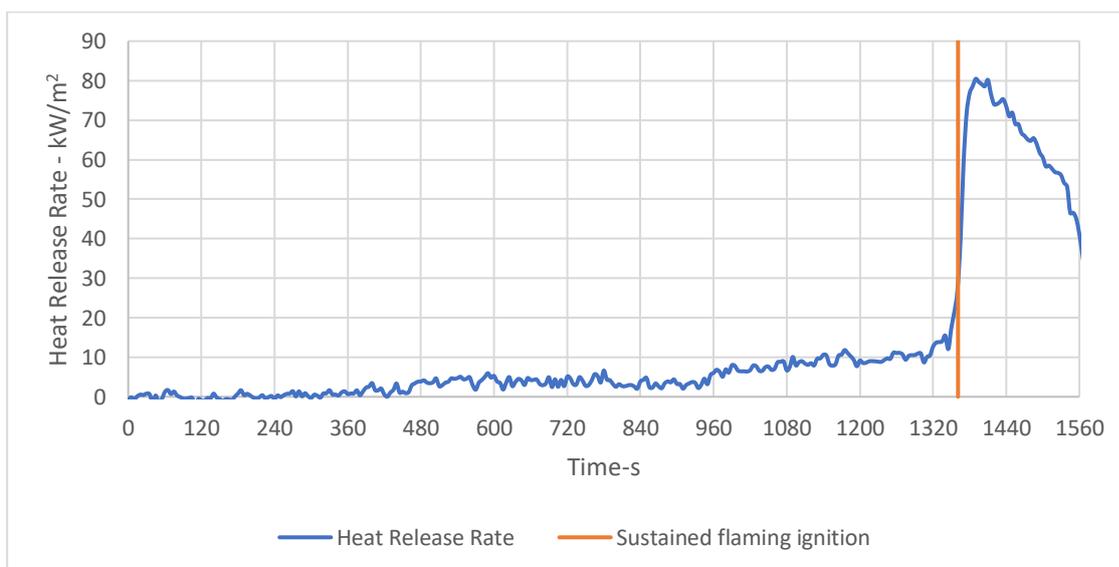
Figure 14 HRR for treated pine (preservative C) 39mm thick exposed to an Irradiance of 12.5kW/m^2

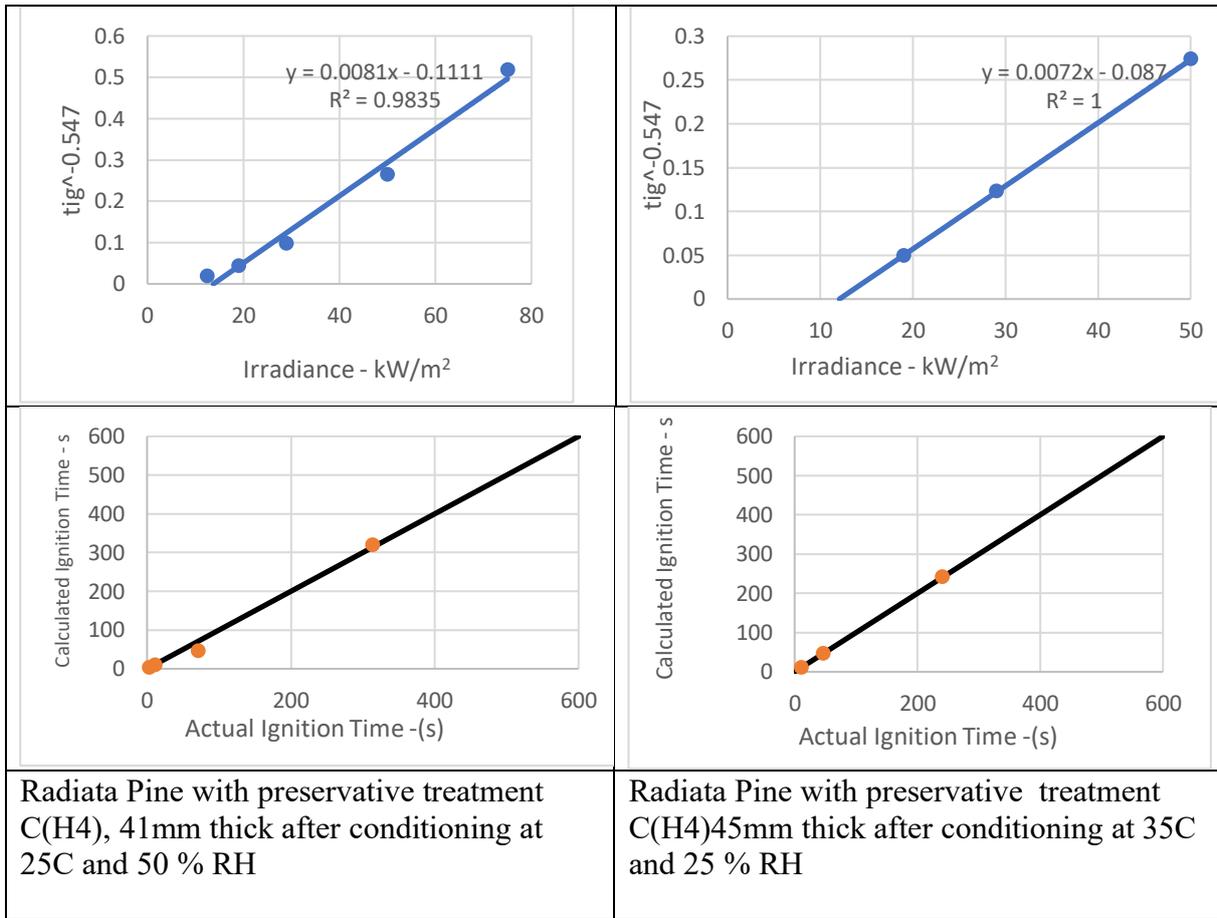
Figure 15 Application of Janssens method for determination of time to ignition for thick specimens of Radiata Pine with preservative treatment C(H4)

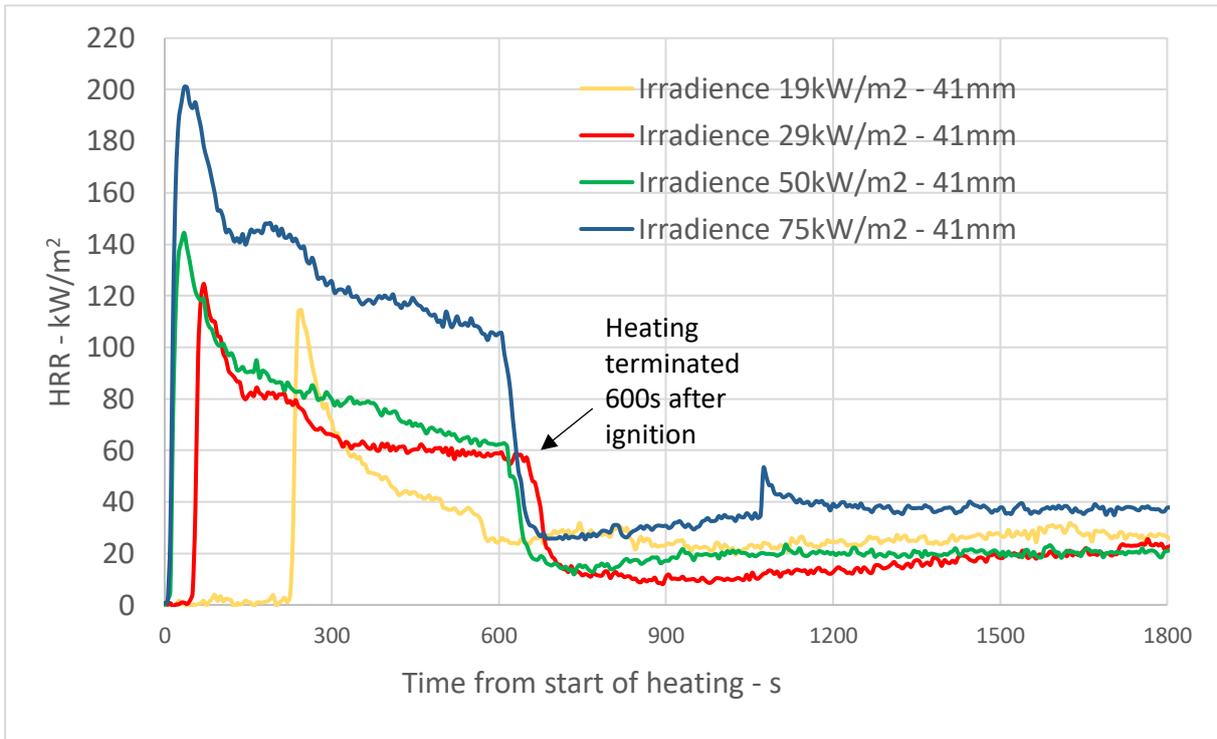
Figure 20 HRR from fire cone calorimeter tests on radiata pine, nominally 41mm thick with preservative treatment C at varying irradiances for a heating duration of 600s after ignition – specimens conditioned at 23°C and 50% relative humidity.

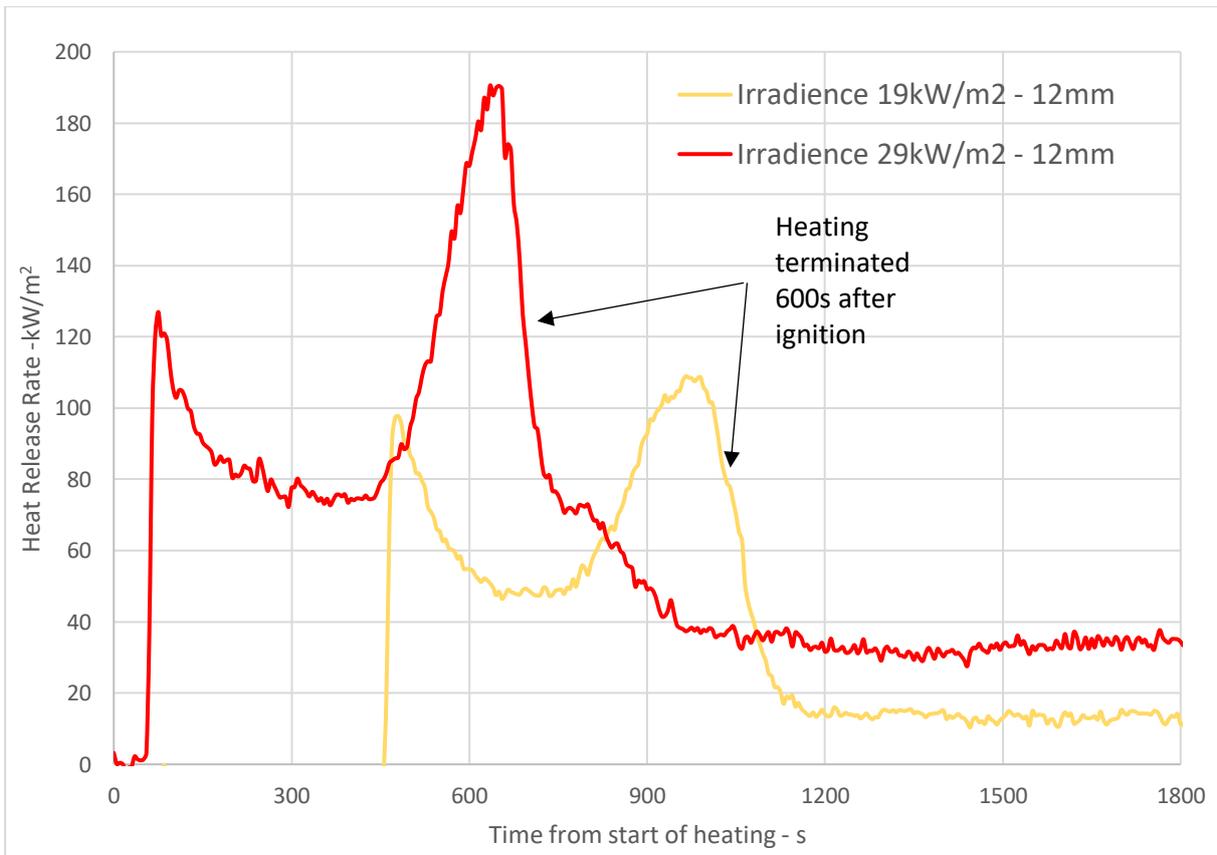
Figure 21 HRR from fire cone calorimeter tests on radiata pine, nominally 12 mm thick with preservative treatment C at varying irradiances for a heating duration of 600s after ignition – specimens conditioned at 23°C and 50% relative humidity.

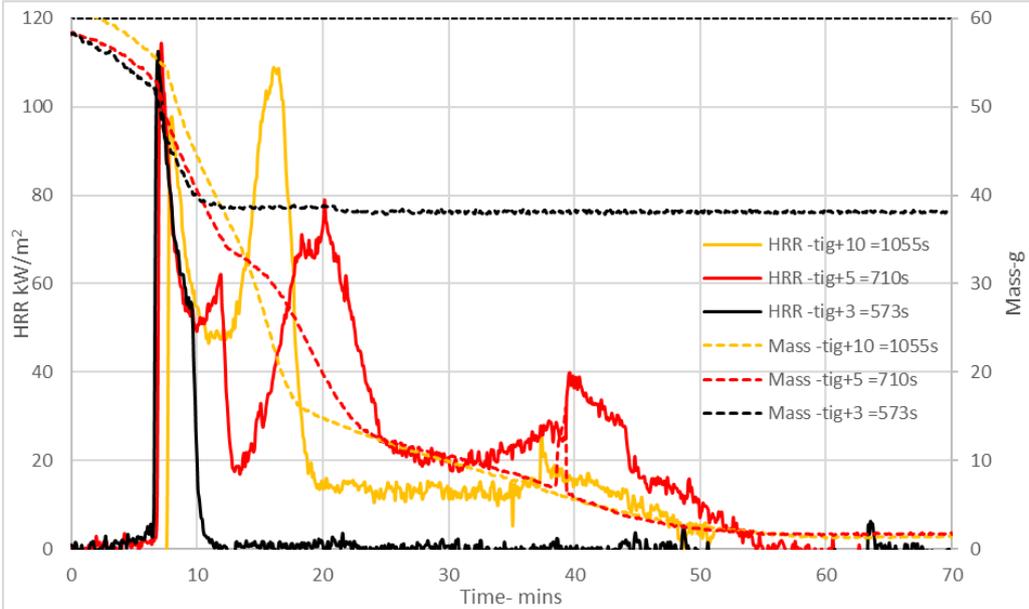
Figure 22 HHR and specimen mass for 12mm thick treated radiata pine subjected to an irradiance of 19kW/m² - black plots show specimen with heating terminated 3 minutes after flaming ignition (total exposure 573s) which self-extinguished when heat source removed; Red and yellow plots show specimens with longer exposures that continued smouldering combustion when heating continued.

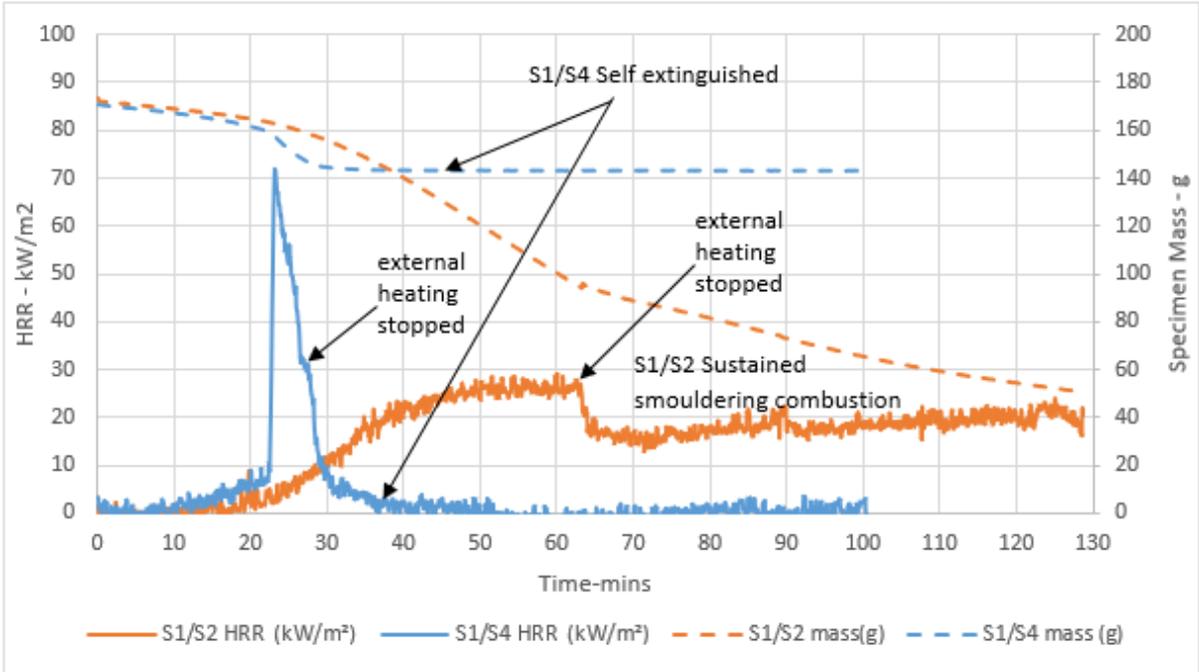
Figure 24 HRR and specimen mass for 45mm thick treated radiata pine subjected to an irradiance of 12.5kW/m^2 - blue plots show specimen with heating terminated 5 minutes after flaming ignition (total exposure 27.75mins); Brown plots show specimen that underwent smouldering ignition only with heating continued for total exposure of 63 minutes

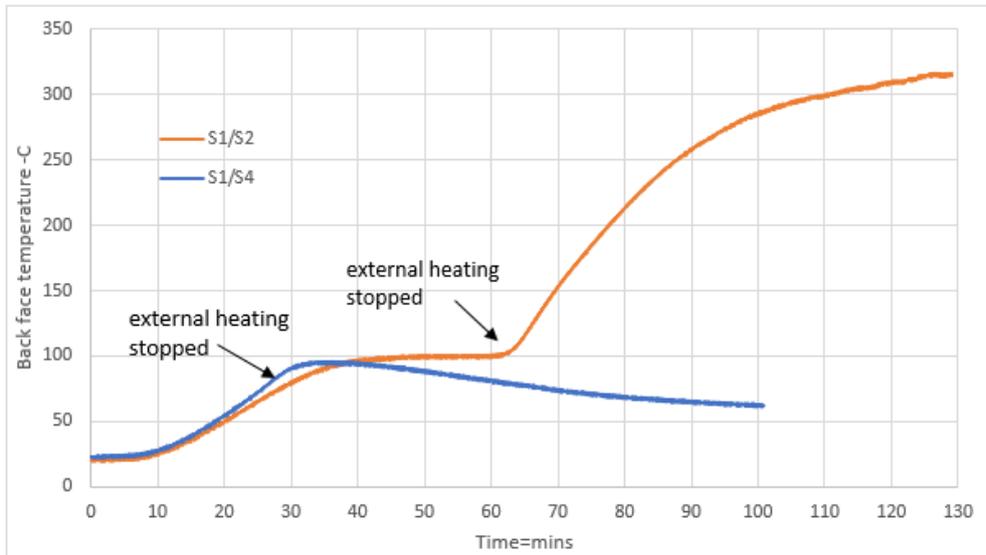
Figure 25 Rear face temperature for 45mm thick treated radiata pine subjected to an irradiance of 12.5kW/m^2 - blue plots show specimen with heating terminated 5 minutes after flaming ignition (total exposure 27.75mins); Brown plots show specimen that underwent smouldering ignition only with heating continued for total exposure of 63 minutes

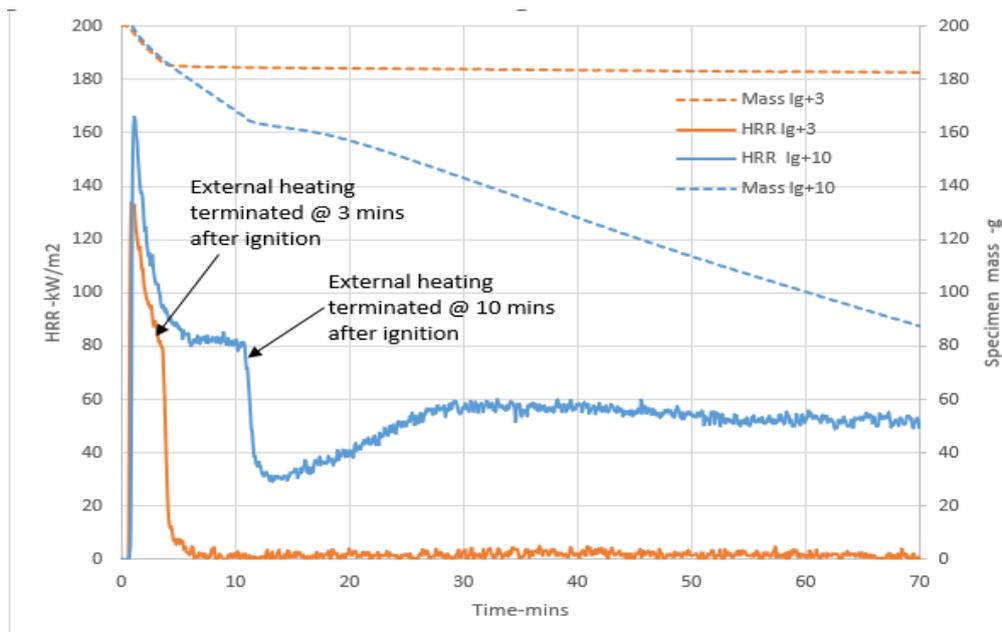
Figure 26 HRR and mass for 45mm thick treated radiata pine subjected to an irradiance of 29kW/m^2 after conditioning at $30^\circ\text{C}/25\%$ r.h.- blue plots show specimen with heating terminated 10 minutes after flaming ignition (total exposure 653s) exhibiting sustained smouldering combustion behaviour; brown plots show specimen with heating terminated 3 minutes after flaming ignition (total exposure 222s) exhibiting self-extinguishment behaviour.

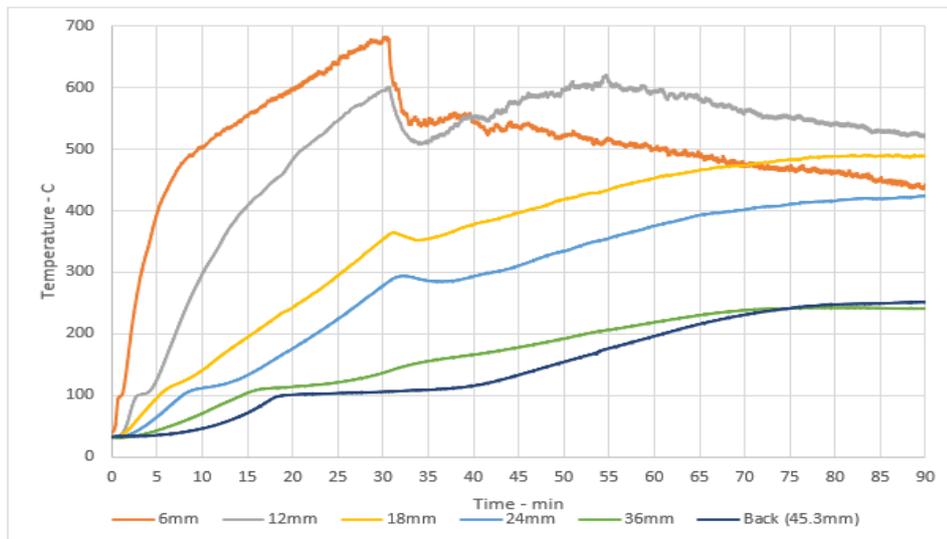
Figure 27 Internal temperatures for 45mm thick treated radiata pine subjected to an irradiance of 29kW/m^2 for 30 minutes after ignition and conditioning at $30^\circ\text{C}/25\%$ r.h.

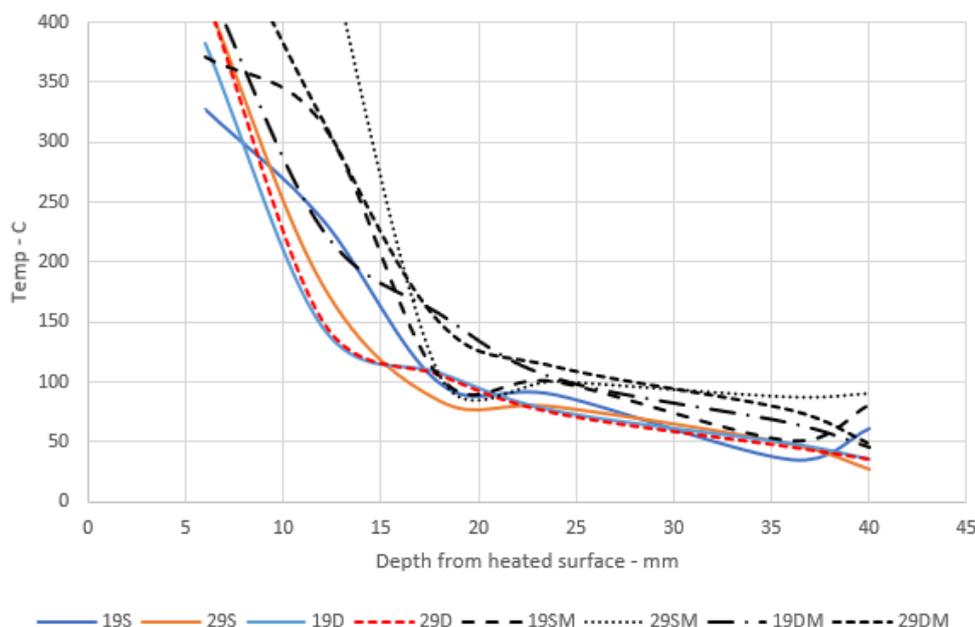
Figure 28 Temperature profiles at termination of heating for specimens subjected to irradiances of 19 and 29kW/m^2 . The suffix S is applied to specimens conditioned at 23°C and 50% r.h. and D to specimens conditioned at 35°C and 25% r.h. Suffix M is applied to marginal cases where there had been substantial smouldering combustion, but late self-extinguishment occurred.

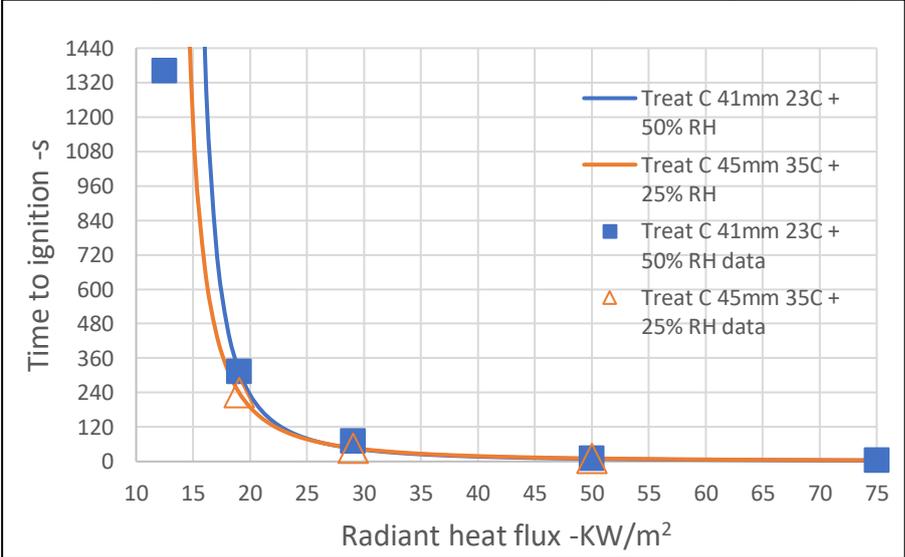
Figure 29 Plots of time to ignition for Radiata Pine with preservative treatment C(H4) based on Janssens method

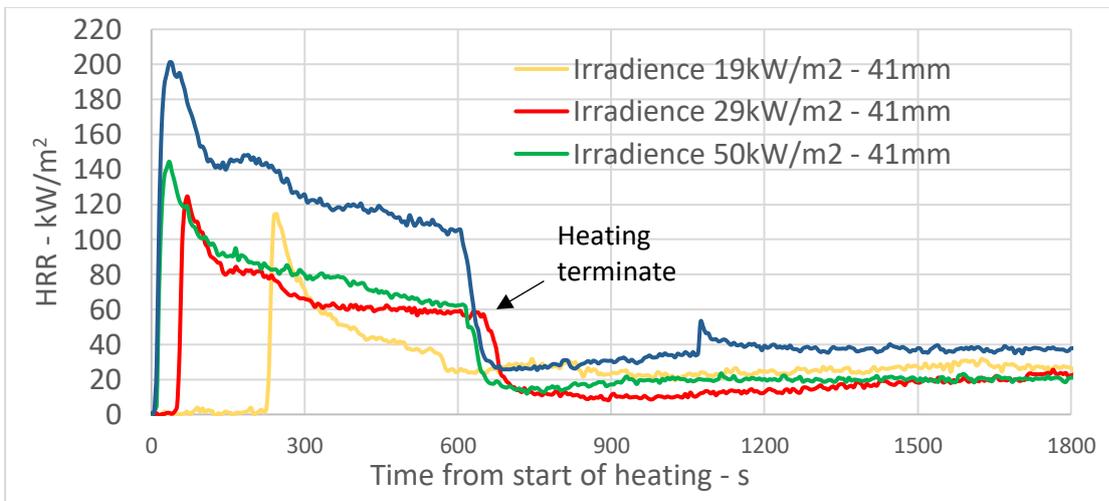
Figure 30 HRR from fire cone calorimeter tests on radiata pine, nominally 41mm thick with preservative treatment C at varying irradiances for a heating duration of 600s after ignition – specimens conditioned at 23°C and 50% relative humidity.

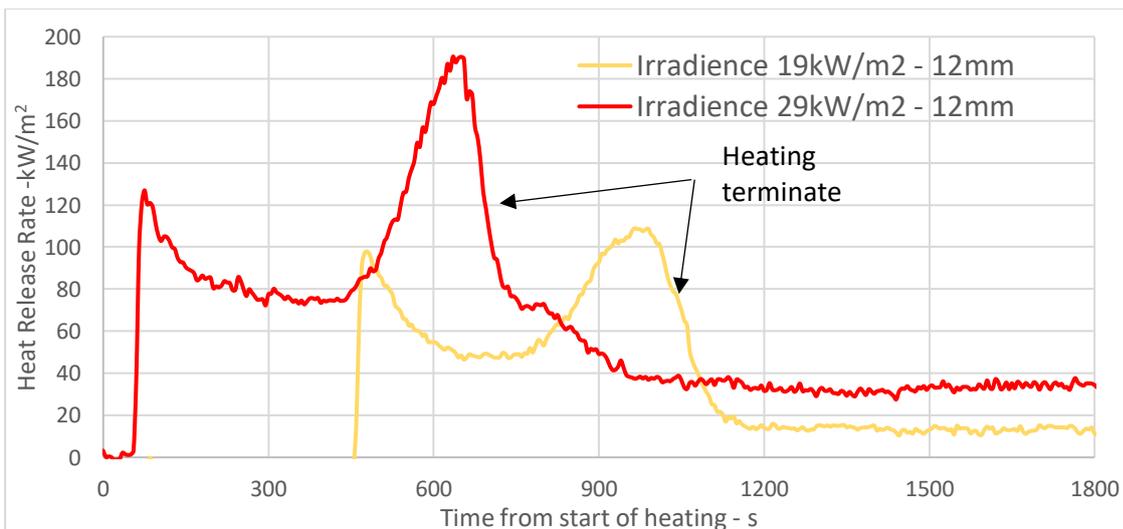
Figure 31 HRR from fire cone calorimeter tests on radiata pine, nominally 12 mm thick with preservative treatment C at varying irradiances for a heating duration of 600s after ignition – specimens conditioned at 23°C and 50% relative humidity.

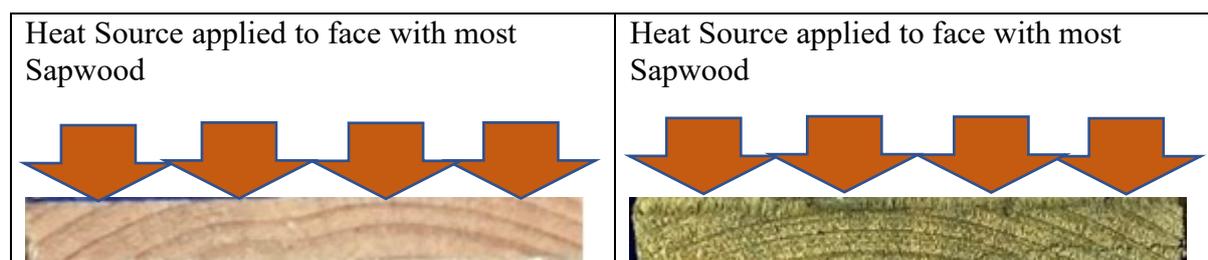
Figure 1 Heat Source Applied to Face with greatest proportion of Sapwood

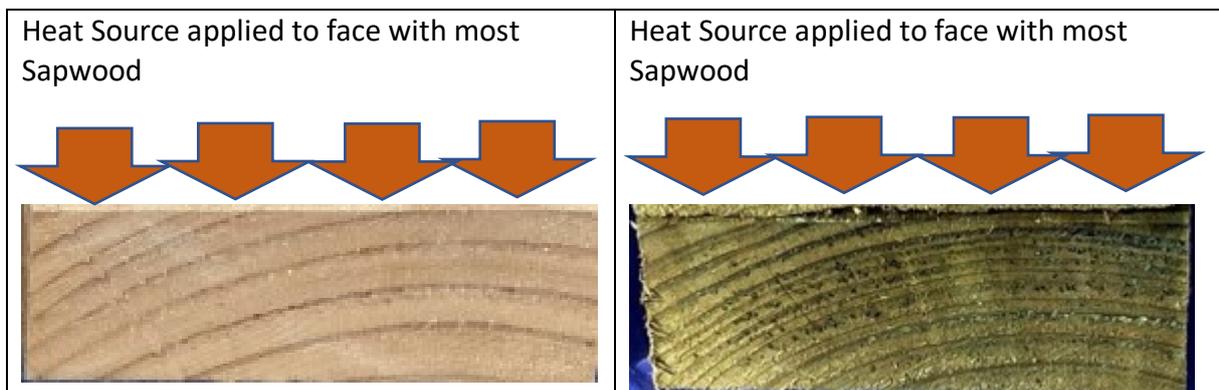
Figure 1 Heat Source Applied to Face with greatest proportion of Sapwood

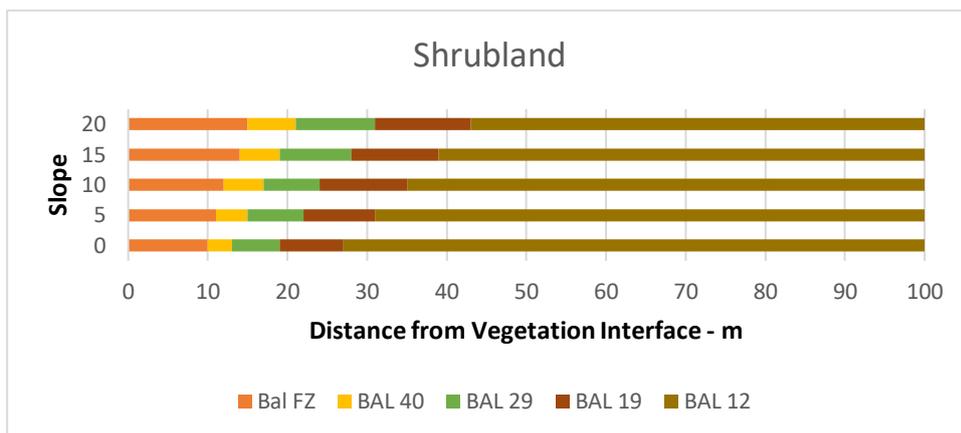
Figure 6 AS 3959 2009 BAL Levels v Distance from Shrubland for varying Downslopes for an FFDI of 100 using the Simple Method Tabulated Values

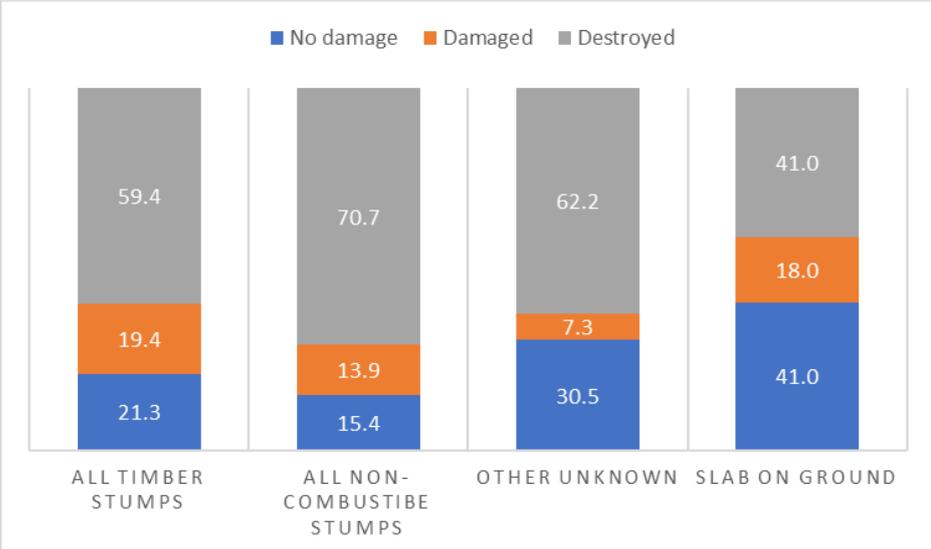
<table border="1"> <caption>Floor Construction Performance Data</caption> <thead> <tr> <th>Construction Element</th> <th>No damage (%)</th> <th>Damaged (%)</th> <th>Destroyed (%)</th> </tr> </thead> <tbody> <tr> <td>ALL TIMBER STUMPS</td> <td>21.3</td> <td>19.4</td> <td>59.4</td> </tr> <tr> <td>ALL NON-COMBUSTIBLE STUMPS</td> <td>15.4</td> <td>13.9</td> <td>70.7</td> </tr> <tr> <td>OTHER UNKNOWN</td> <td>30.5</td> <td>7.3</td> <td>62.2</td> </tr> <tr> <td>SLAB ON GROUND</td> <td>41.0</td> <td>18.0</td> <td>41.0</td> </tr> </tbody> </table>	Construction Element	No damage (%)	Damaged (%)	Destroyed (%)	ALL TIMBER STUMPS	21.3	19.4	59.4	ALL NON-COMBUSTIBLE STUMPS	15.4	13.9	70.7	OTHER UNKNOWN	30.5	7.3	62.2	SLAB ON GROUND	41.0	18.0	41.0

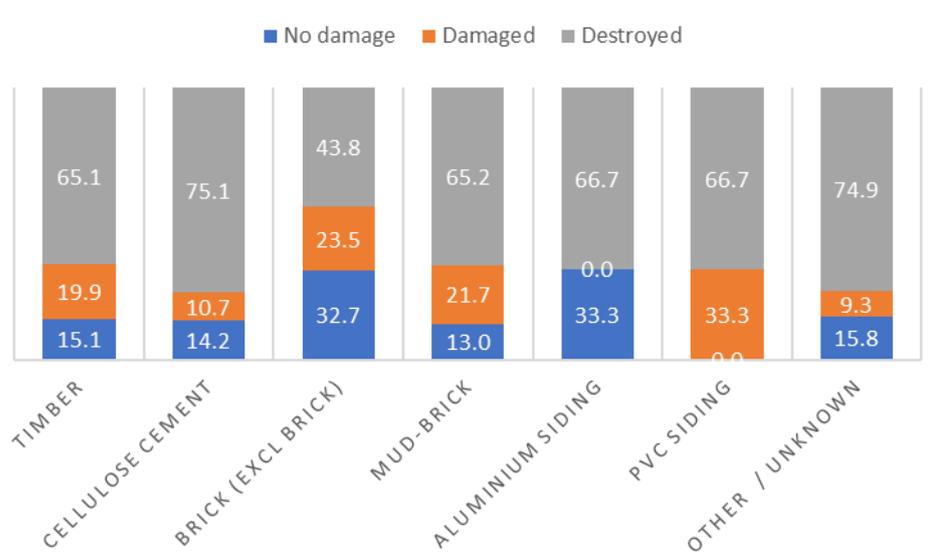
<table border="1"> <caption>External Wall Cladding Performance Data</caption> <thead> <tr> <th>Construction Element</th> <th>No damage (%)</th> <th>Damaged (%)</th> <th>Destroyed (%)</th> </tr> </thead> <tbody> <tr> <td>TIMBER</td> <td>15.1</td> <td>19.9</td> <td>65.1</td> </tr> <tr> <td>CELLULOSE CEMENT</td> <td>14.2</td> <td>10.7</td> <td>75.1</td> </tr> <tr> <td>BRICK (EXCL BRICK)</td> <td>32.7</td> <td>23.5</td> <td>43.8</td> </tr> <tr> <td>MUD-BRICK</td> <td>13.0</td> <td>21.7</td> <td>65.2</td> </tr> <tr> <td>ALUMINIUM SIDING</td> <td>33.3</td> <td>0.0</td> <td>66.7</td> </tr> <tr> <td>PVC SIDING</td> <td>0.0</td> <td>33.3</td> <td>66.7</td> </tr> <tr> <td>OTHER / UNKNOWN</td> <td>15.8</td> <td>9.3</td> <td>74.9</td> </tr> </tbody> </table>	Construction Element	No damage (%)	Damaged (%)	Destroyed (%)	TIMBER	15.1	19.9	65.1	CELLULOSE CEMENT	14.2	10.7	75.1	BRICK (EXCL BRICK)	32.7	23.5	43.8	MUD-BRICK	13.0	21.7	65.2	ALUMINIUM SIDING	33.3	0.0	66.7	PVC SIDING	0.0	33.3	66.7	OTHER / UNKNOWN	15.8	9.3	74.9

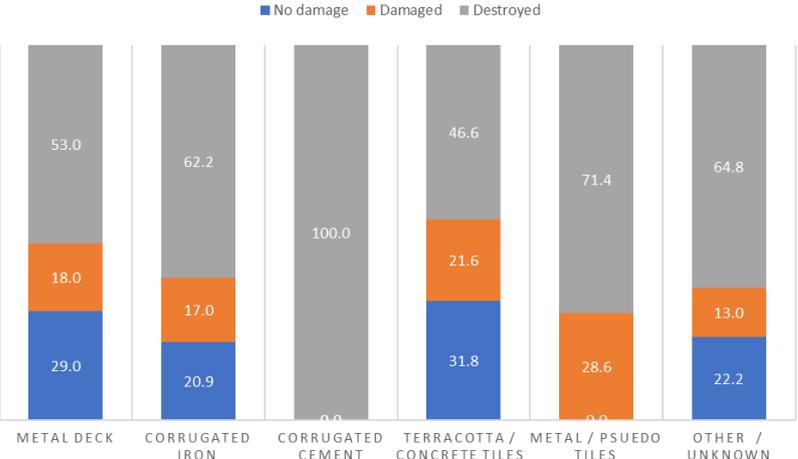
<table border="1" data-bbox="443 286 1241 745"> <caption>Roof Cladding Damage Status Data</caption> <thead> <tr> <th>Construction Element</th> <th>No damage (%)</th> <th>Damaged (%)</th> <th>Destroyed (%)</th> </tr> </thead> <tbody> <tr> <td>METAL DECK</td> <td>29.0</td> <td>18.0</td> <td>53.0</td> </tr> <tr> <td>CORRUGATED IRON</td> <td>20.9</td> <td>17.0</td> <td>62.2</td> </tr> <tr> <td>CORRUGATED CEMENT</td> <td>0.0</td> <td>0.0</td> <td>100.0</td> </tr> <tr> <td>TERRACOTTA / CONCRETE TILES</td> <td>31.8</td> <td>21.6</td> <td>46.6</td> </tr> <tr> <td>METAL / PSEUDO TILES</td> <td>0.0</td> <td>28.6</td> <td>71.4</td> </tr> <tr> <td>OTHER / UNKNOWN</td> <td>22.2</td> <td>13.0</td> <td>64.8</td> </tr> </tbody> </table>		Construction Element	No damage (%)	Damaged (%)	Destroyed (%)	METAL DECK	29.0	18.0	53.0	CORRUGATED IRON	20.9	17.0	62.2	CORRUGATED CEMENT	0.0	0.0	100.0	TERRACOTTA / CONCRETE TILES	31.8	21.6	46.6	METAL / PSEUDO TILES	0.0	28.6	71.4	OTHER / UNKNOWN	22.2	13.0	64.8
