Final Report
Project NV054

Investigation of Preservative Treated Plantation Timber Fencing and Sleeper Markets in Bushfire Prone Areas

Project No: NIF144-2122 [NV054]

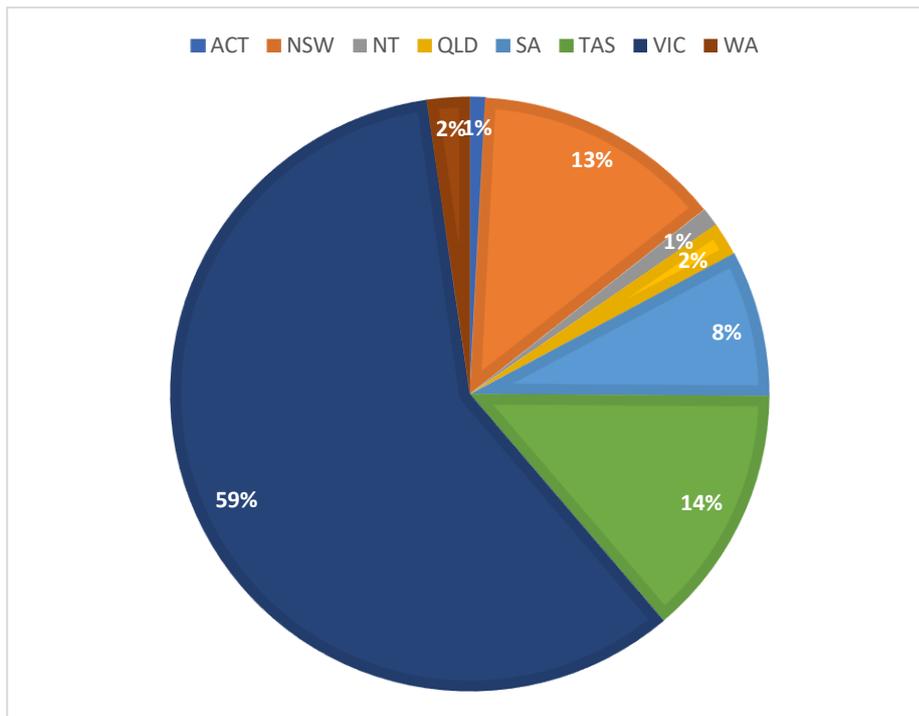
Figure 9 Bushfire fatalities by State and Territory between 1965 and 2011 derived from (Blanchi R, Leonard J et al. 2012)
